SEISMIC PERFORMANCE OF PRECAST HOLLOW-CORE FLOORS WITH MODERN DETAILING: A CASE STUDY

ABSTRACT

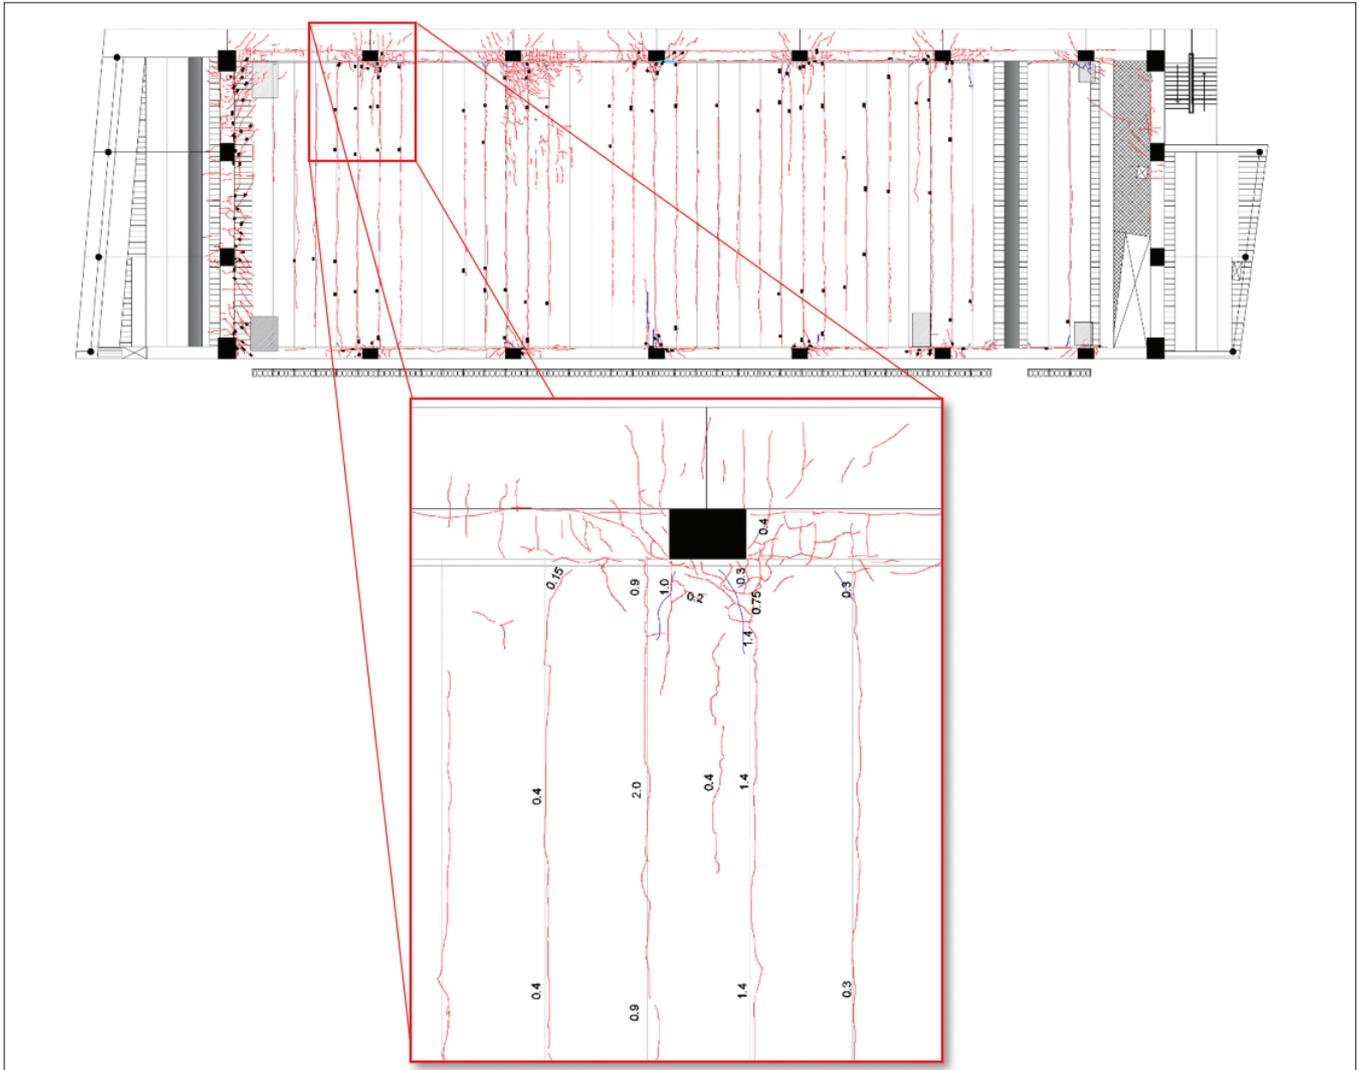
The damage in the topping of the floors was observed throughout the building. Figure 8 shows one-floor diaphragm damage as an example of the typical damage observed and marked with red lines. The topping damage primarily consisted of longitudinal cracks between adjacent units and some longitudinal cracking within the width of units. These longitudinal cracks had residual widths ranging from 0.3 mm to 7 mm, with larger crack widths typically occurring between units. In the areas adjacent to the columns, concentrated transverse and longitudinal cracking with crack widths ranging from hairline to 4 mm wide were observed. No mesh rupture was observed in the topping as ductile mesh was used. Support ledge spalling at the columns and plastic hinge

Figure 8: Crack map sample from the second floor in Pier 3 with floor top cracking marked in red, soffit cracks marked in blue, zones was observed in multiple locations in the building (e.g. Figure 9). However, no loss of unit support was observed due to the ledge reinforcement detailing used in this building.

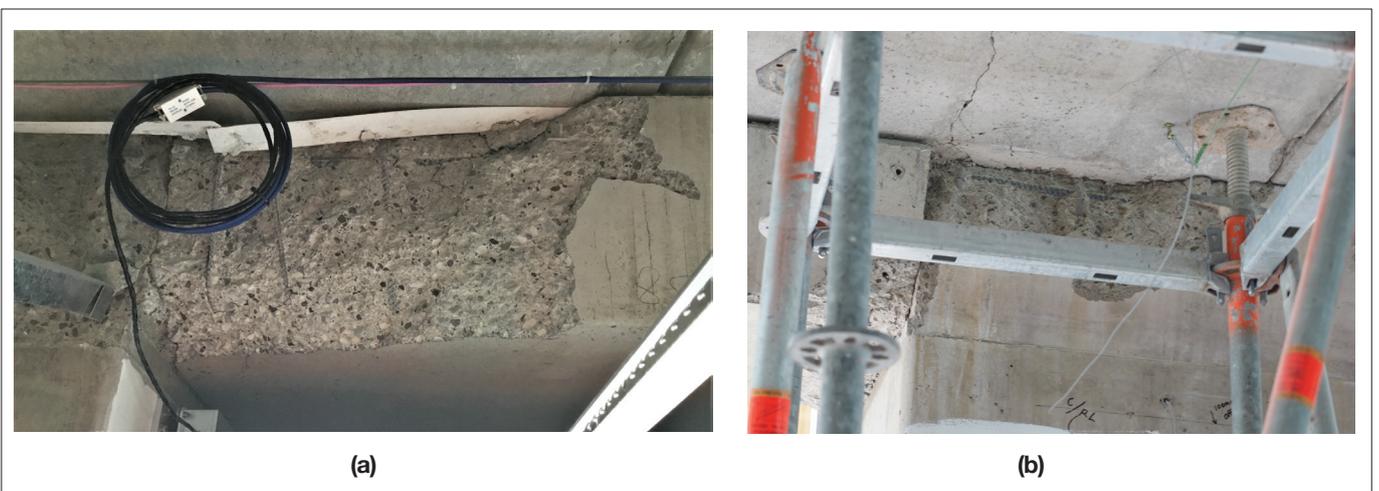
Figure 9: Significant support ledge spalling observed at different locations in the building (a) Pier 3 level 1 (modified from Siddiqui et al. (2019a)) (b) Pier 2 level 1

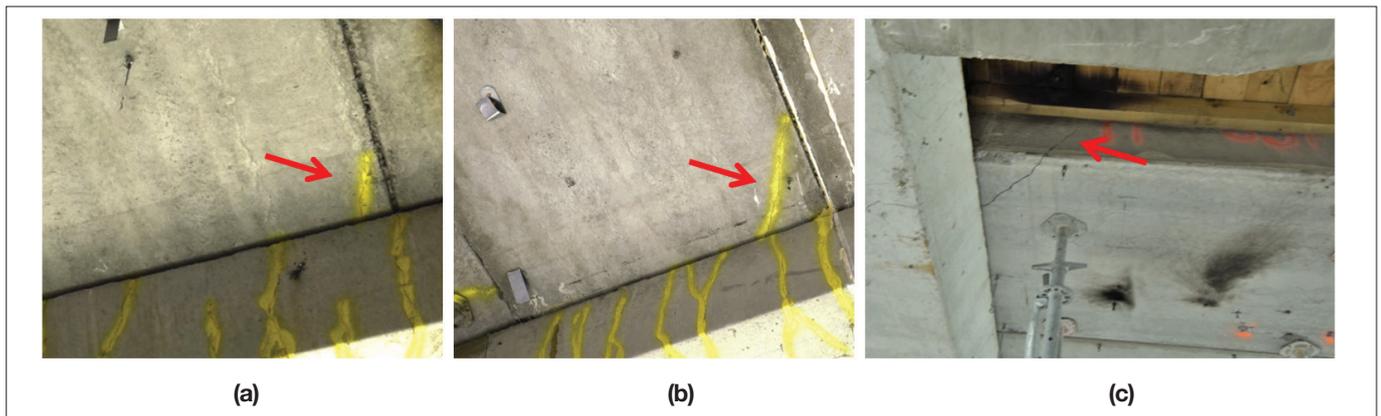
As for the hollow-core units damage observed at the soffit, a significant proportion of the hollow-core floor units in the building sustained some level of damage due to deformation incompatibilities between the hollow-core units and the supporting frames under seismic demands. The corners of the hollow-core units were found to be damaged in many units throughout the building. This corner cracking was found to occur in units regardless of their location in the building (i.e. seated over a column, within the plastic hinge zone or outside the plastic hinge zone) with various degrees of damage, as shown in Figure 10. Given the prevalence of this crack type, with evidence of grout seeping out of one unit corner crack in the building (Figure 11a), this corner cracking is also being observed in buildings located in Auckland that have not been subjected to earthquake loading (Figure 11b). These corner cracks were likely caused by non-seismic damage. Such damage could have occurred during production due to the saw-cut not being deep

enough, the saw blade binding when the member cambers, or uneven handling due to pick-up devices not being level (Hoisington et al. 1983).

Another reason for this cracking could be damage initiation during construction, in which the units are usually placed on their side first while installing them in their final location. This installation method could place localized stress on the corners of the units at the supports resulting in the observed cracking. While it is likely these corner cracks were initiated during the production or construction phases, it is expected that these corner cracks opened up during the earthquake and propagated through one or two webs, reducing the shear capacity of the units. Moreover, where the side of the units was visible, it was found that the corner cracking observed from the bottom of the units propagated through the external web of the unit (Figure 10c). Corner cracking propagation through the external webs could not be confirmed for units seated within the middle of the floor (Figure 10a and Figure 10b).

Figure 10: (a) minor hairline corner crack (b) Moderate corner crack (c) corner cracking propagating through exterior web when visible

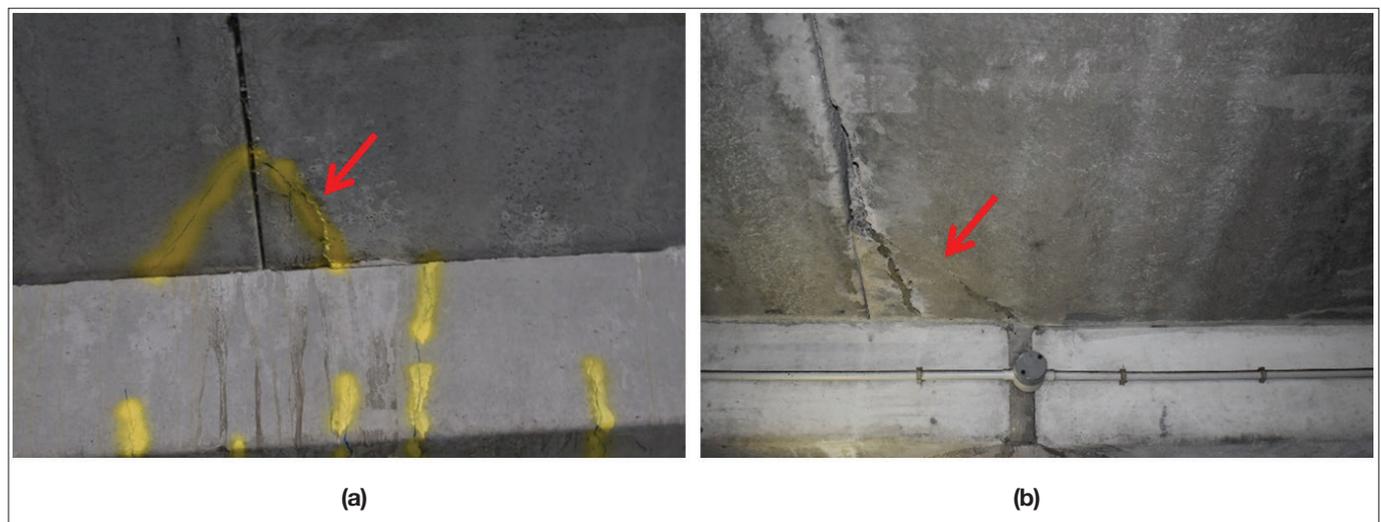
Figure 11: (a) corner crack with grout seeping out observed in the building investigated (b) corner crack observed in a carpark in Auckland

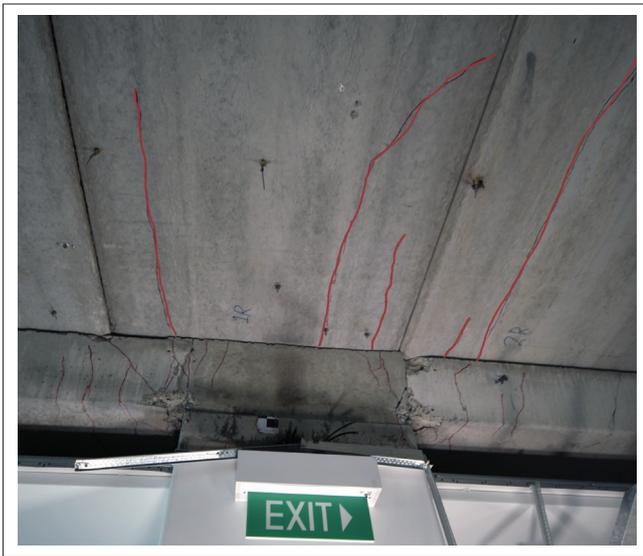
In addition to the corner cracking in the soffit of the units, longitudinal cracking in the bottom flange of the hollow-core units was also observed in multiple units with varying degrees of severity from hairline cracking to wide cracks that extended the full length of the unit. Longitudinal cracking might be problematic if the cracking crossed a web (Figure 12) which was typically found in units seated within the plastic hinge zone. Longitudinal cracking of units seated within the plastic hinge region occurs due to the deformation of the supporting beam under seismic demands and can be accompanied by web splitting that may result in the separation of the unit's bottom half from the unit's top half. Web splitting was identified in the units seated within the plastic hinge region via borescope.

Figure 12: longitudinal cracking of HC unit soffit

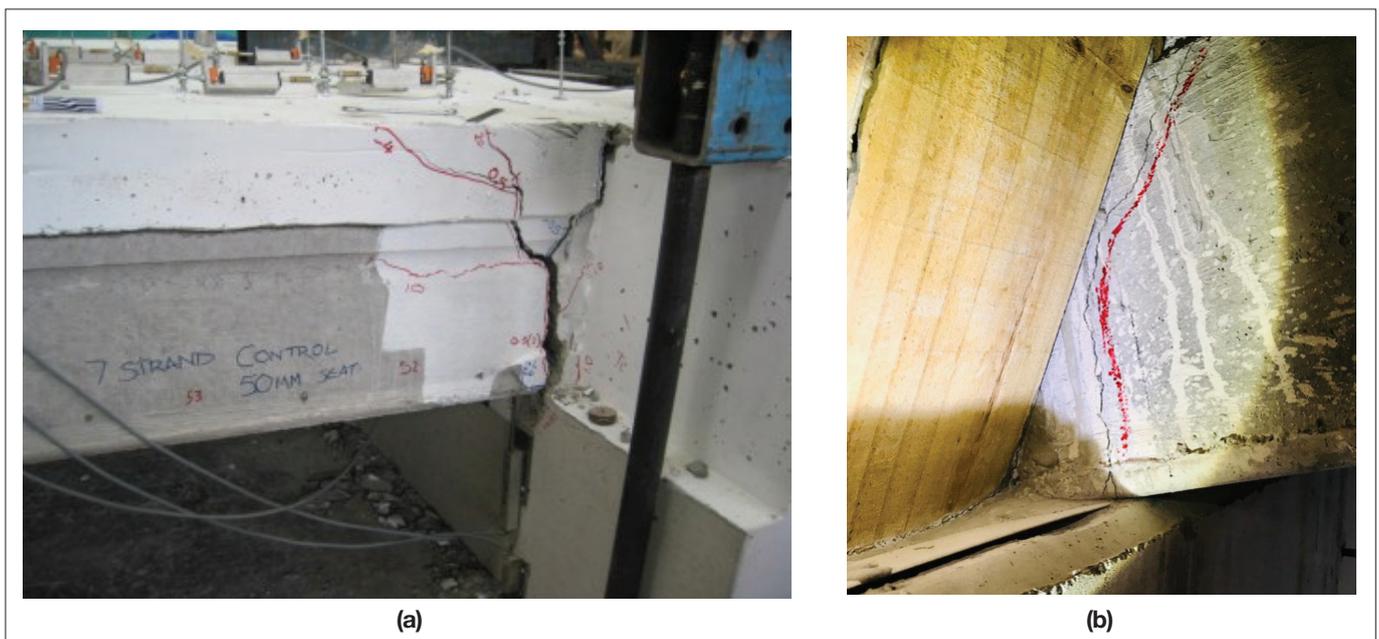
Figure 13: (a) positive moment failure in test conducted by Bull & Matthews (2003) (b) web cracking observed from unit side

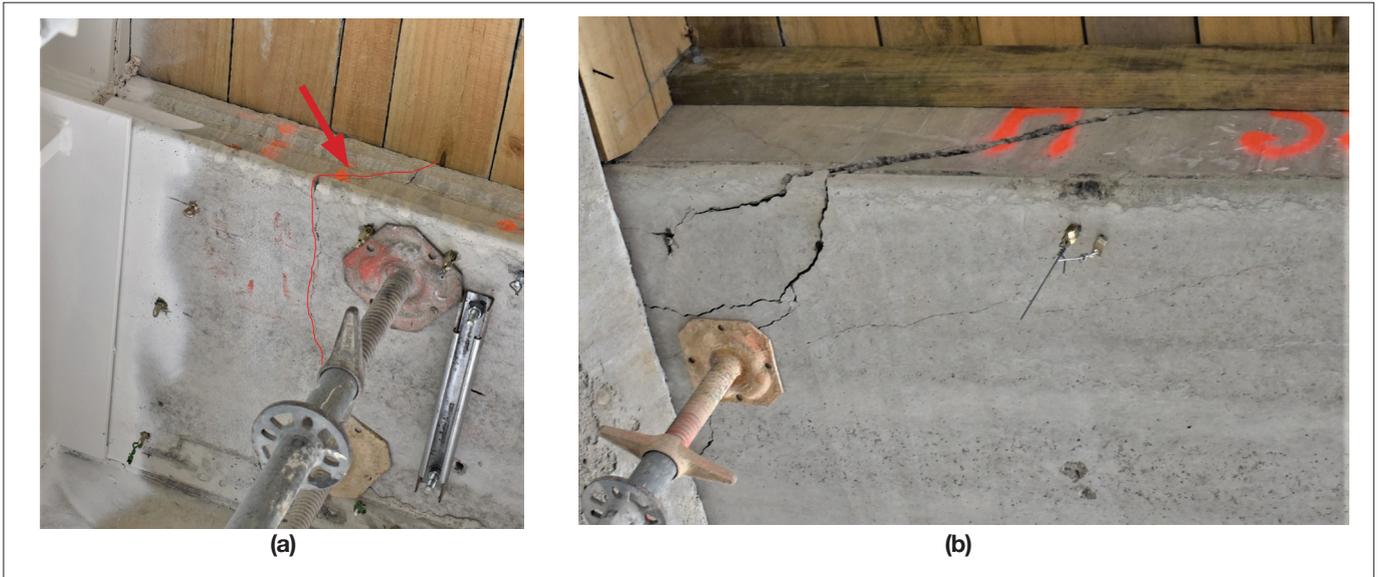
Transverse cracking in the soffit of the precast hollow-core units was also observed in multiple units. Based on previous research observations (Fenwick et al. 2010), such damage indicates the propagation of cracking through the unreinforced unit webs (e.g. Figure 13a). Several floor units throughout the building were temporarily shored immediately after the earthquake as the damage observed in these units suggested that their vertical load-carrying capacity had been compromised. Moreover, web cracking was evident in units where the side of the hollow-core unit was visible, with no signs of damage observed at the unit's soffit (Figure 13b). Such observations not only reinforce the concerns regarding the risk these floors possess - given the inability to inspect these webs without invasive techniques such as using a borescope - but also raise concerns regarding the efficiency of the low friction bearing strip to suppress positive moment damage. A preliminary explanation of the web damage observed (Figure 13b) would be due to the filled cores with R16 bars trapping the unit and not allowing the unit to slide over the low friction bearing strip. Furthermore, cracking of hollow-core unit's external webs was observed in multiple units where the side of the unit was visible (Figure 14). In one of these units with exposed sides, severe web cracking of approximately 30 mm was observed (Figure 14b).

Figure 14: (a) transverse cracking observed at the soffit of the HC unit away from the support propagating through the web (b) HC unit corner severely damaged and unit dropping with severe web cracking (about 30 mm) propagating through the web

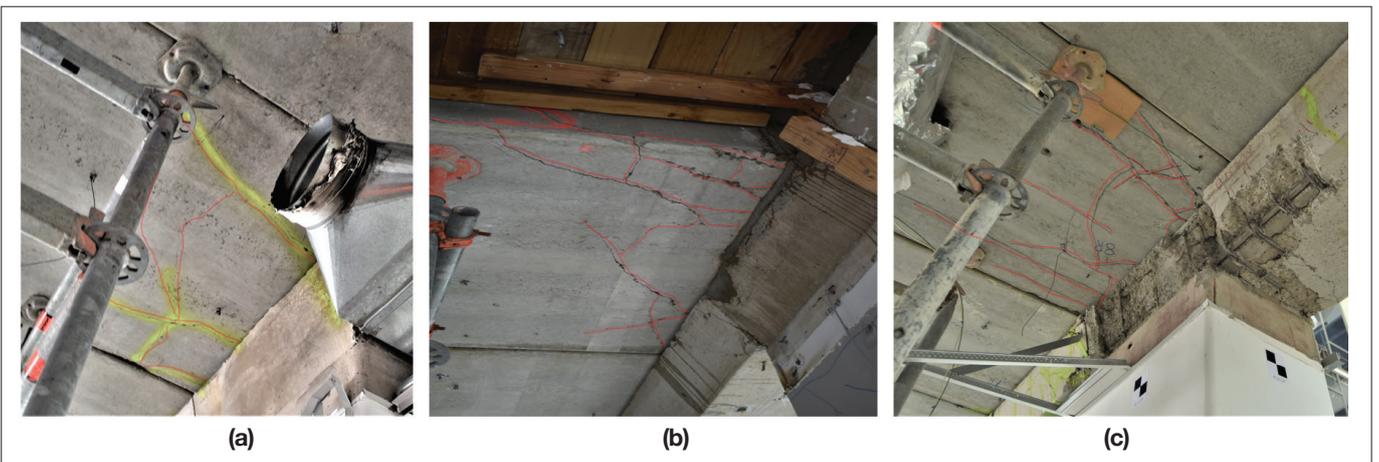
In addition to the units' corner, longitudinal, and transverse cracking, a damage pattern that has not been previously observed in either test specimens or other hollow-core building damage reports was observed repeatedly throughout the building. The damage pattern primarily consists of the two corners of the unit ends being cracked accompanied by a curved transverse cracking about 300 mm away from the support (Figure 15). This "transverse hoop" damage pattern was found in units seated on a column, where these units have been subjected to a combination of rotational and bending demands in both transverse and longitudinal directions of the units during the earthquake shaking. Units exhibiting this transverse hoop damage pattern were located on different floors that were subjected to different drift demands.

Figure 15: Previously unidentified repeated damage pattern highlighted in red (a) Pier 2 level 4 (b) Pier 3 level 2 (c) Pier 2 level 3

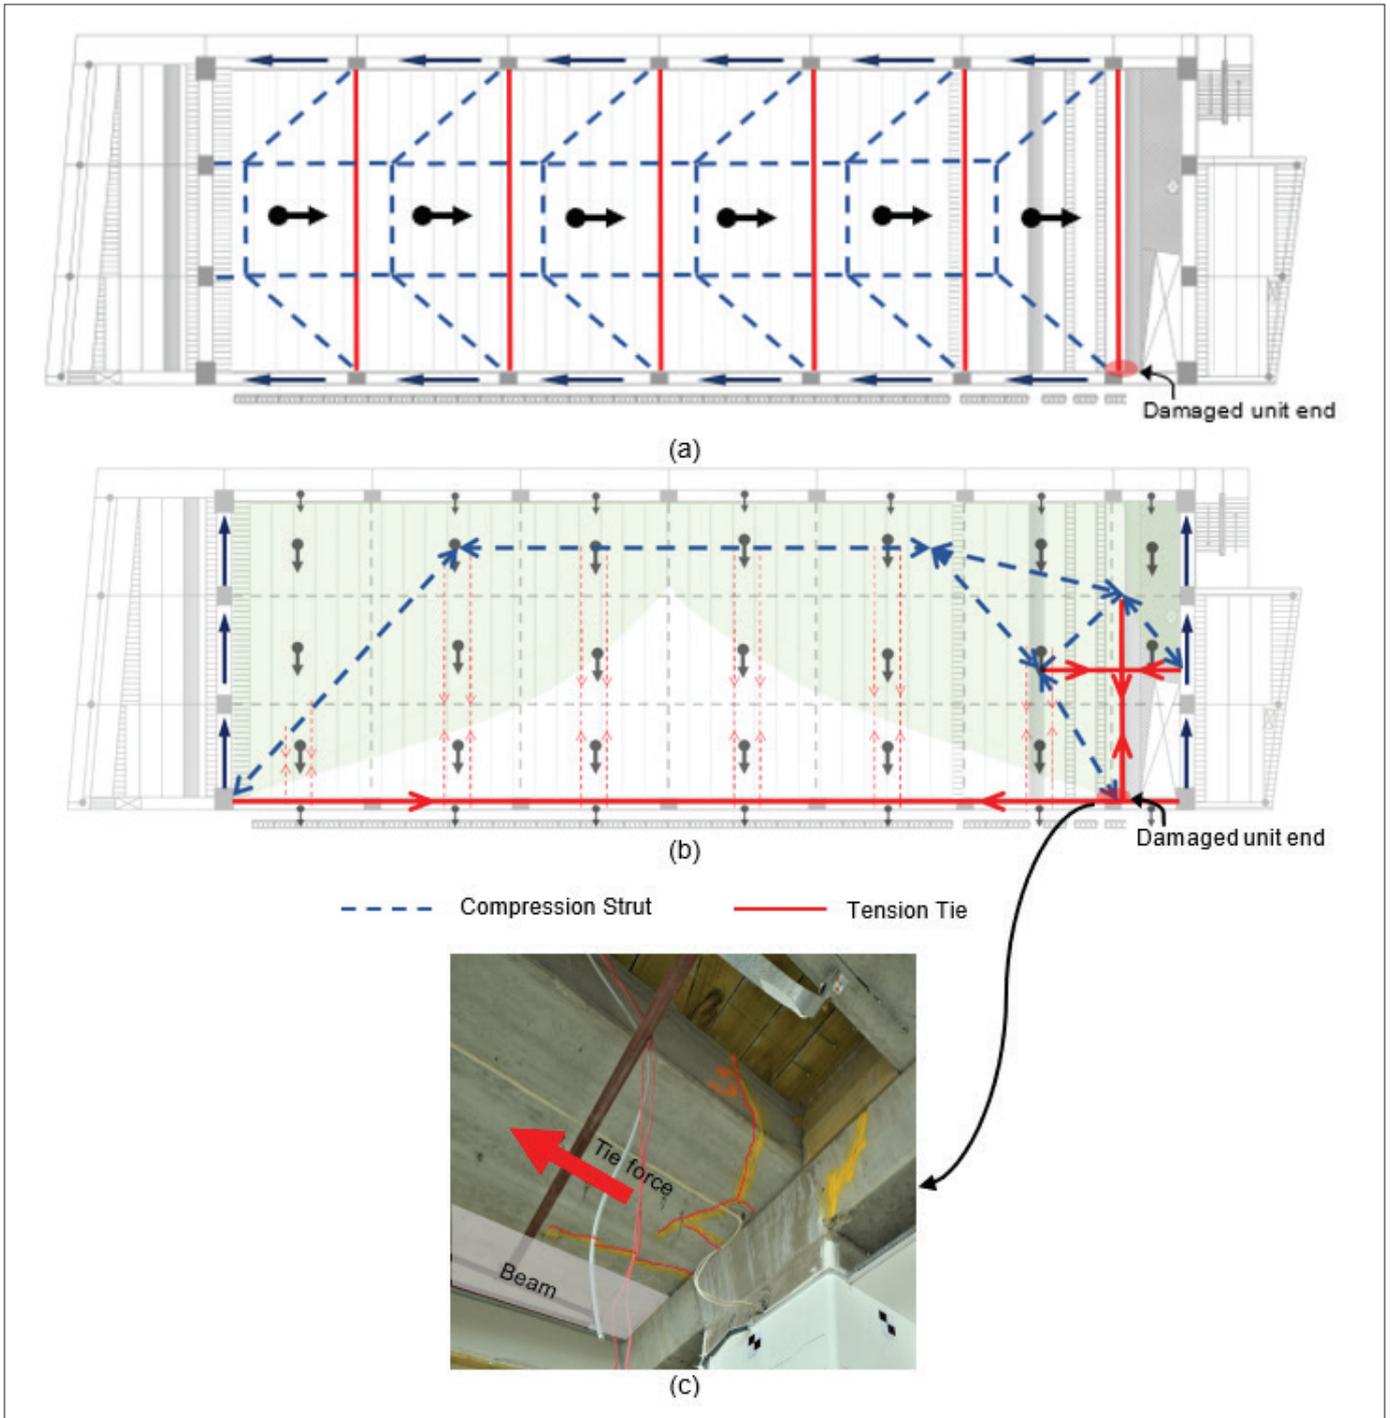
Finally, transverse cracking at a unit soffit accompanied by web cracking (Figure 16c) was observed at the top

storey where the imposed storey drift demand was as low as 0.6% in the longitudinal direction of the unit and 1.0% in the transverse direction. Preliminary analysis suggests that diaphragm demands (Figure 16) due to higher floor accelerations may have influenced the occurrence of such damage at such low drift demands. Almost half of the floor inertial load in the longitudinal direction needs to be transferred to the moment-resisting frame through a tension tie due to the presence of a floor opening in the shown location. Although a tie beam was present, the tensile forces from the inertial loads, in addition to the relatively small deformation demands imposed on the unit from the supporting frame, was sufficient to cause the damage pattern shown in Figure 16c. Such damage highlights the challenges of ensuring good performance of hollow-core floors even when incorporated in regular floor diaphragms.

Figure 16: Simplified Strut and Tie (S-T) model for diaphragm inertial forces and damage observed at top storey with low drift demands highlighted in red, (a) S-T model for inertial loads in the transverse direction (b) S-T model for inertial loads in the longitudinal direction (c) damage observed in hollow-core unit at top storey

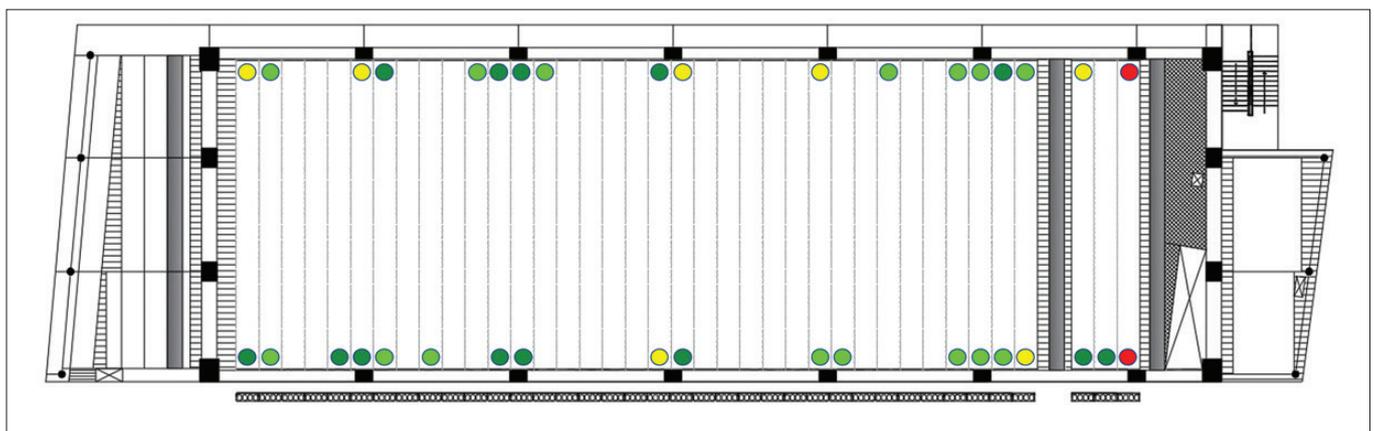
Figure 17: Floor damage distribution example, Pier 3 - level 2

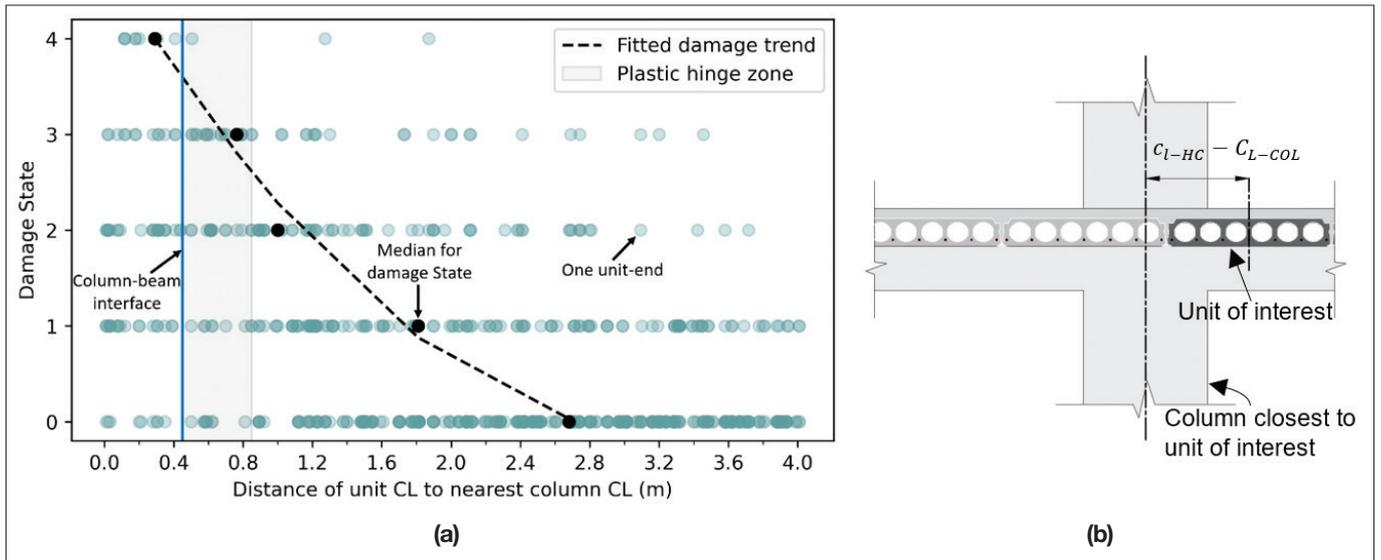
of engineering judgement involved in interpreting the significance of different damage states, and as such, some potential variance in evaluations can result. However, the interpretation of damage severity was based on available research information on the seismic performance of these floors (Bull et al., 2009; Fenwick et al., 2010). According to the classification criteria defined herein, the damage severity for each end of the hollow-core units was mapped for each floor. An example is shown in Figure 17. Then the damage severity for each end of the hollow-core units was plotted against each unit location relative to the nearest column for 684 unit-ends (i.e. 342 units) (Figure 18). It was noted that there was a trend for the damage severity, where the

closer the unit was to a column, the higher the degree of damage. More severe damage was found in units seated either fully or partially on a column (referred to as ‘beta units’), where the precast floor units were subjected to localised deformation to accommodate the deformation of the supporting seismic and gravity systems. These observations highlighted the susceptibility of hollow-core floor units to sustain a higher degree of damage when seated within the plastic hinge regions. The plastic hinge length was taken as half of the supporting beam depth (effective plastic hinge length $\sim 0.5h_b$, according to the yellow chapter-C5).

Figure 18: (a) Damage severity trend relative to unit location (centreline of unit relative to centreline of nearest column) (b) illustrative schematic of the units' location used
