LOAD-PATH AND STIFFNESS DEGRADATION OF FLOOR DIAPHRAGMS IN REINFORCED CONCRETE BUILDINGS SUBJECTED TO LATERAL LOADING

PART I: EXPERIMENTAL OBSERVATIONS

Part I of II in this journal series details the full-scale super-assembly experiment conducted on a floor diaphragm at different damage states and the observed behaviour during testing.

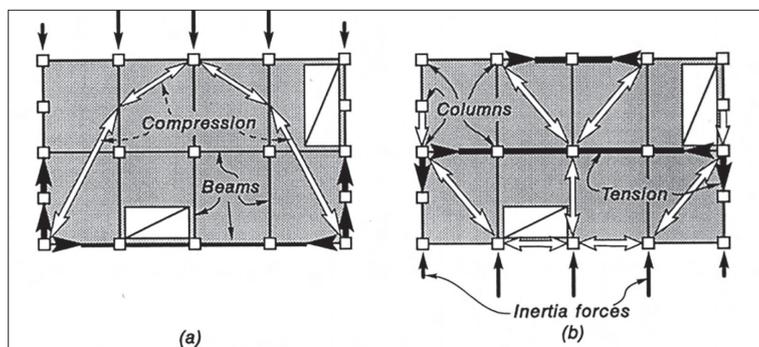
Figure 1: Strut-and-tie load-paths, using diagonal compression fields, for different directions of seismic forces (Paulay 1996)

the flow of internal forces for many aspects of reinforced concrete design and assumes that all compression forces are borne through the concrete in compression “struts” and all tension forces are transferred through steel reinforcing acting as tension “ties”. Concrete is assumed to carry no tension and steel is assumed to carry no compression. Examples of typical strut-and-tie solutions are displayed in Figure 1.

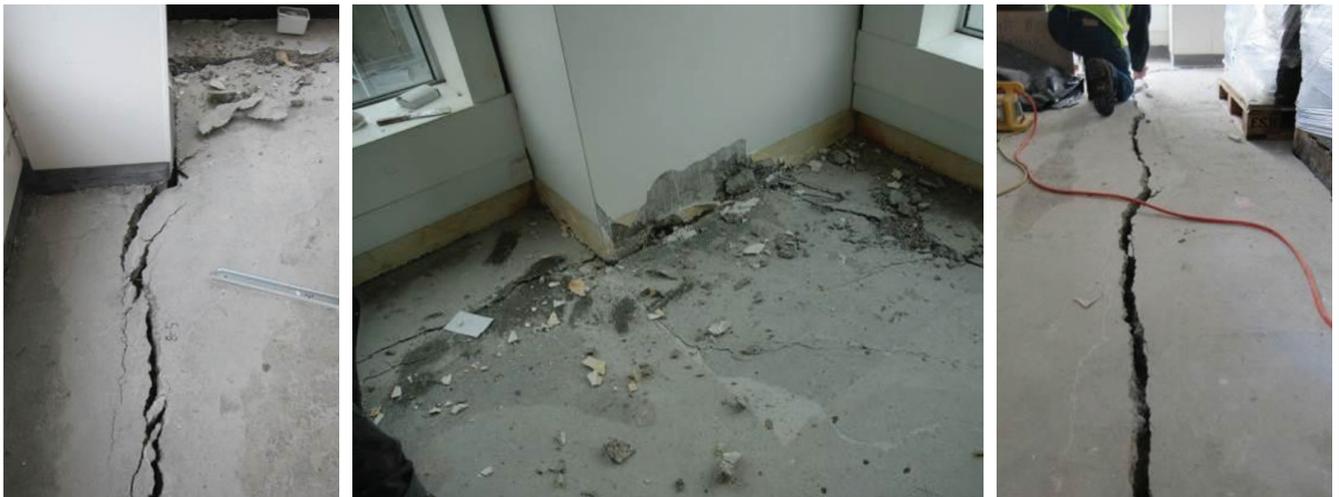
(a) Significant floor perimeter cracking following the 2011 Christchurch earthquakes (Kam et al. 2011)

Figure 2: Examples of significant floor perimeter cracking and loss of compression strut load paths

Evidence of possible deficiencies with current diaphragm design assumptions for buildings with reinforced concrete frame structures with precast concrete floors was observed in the aftermath of the 2011 Christchurch earthquake. Floors were found with large cracks and openings around their perimeter where they connect to supporting beam and column elements as shown in Figure 2a. This confirmed previous concerns, for example as shown in Figure 2b.

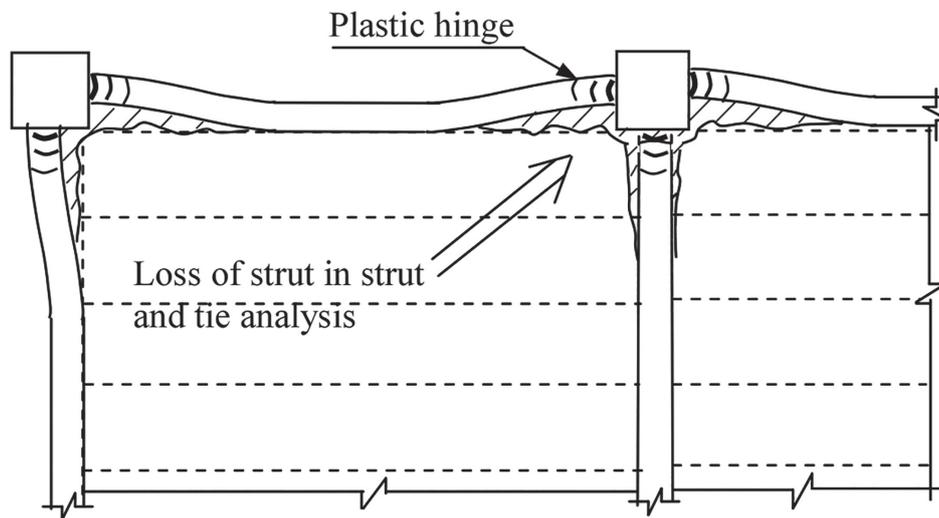
(b) Loss of strut landing points due to significant perimeter cracking (Fenwick et al 2010)

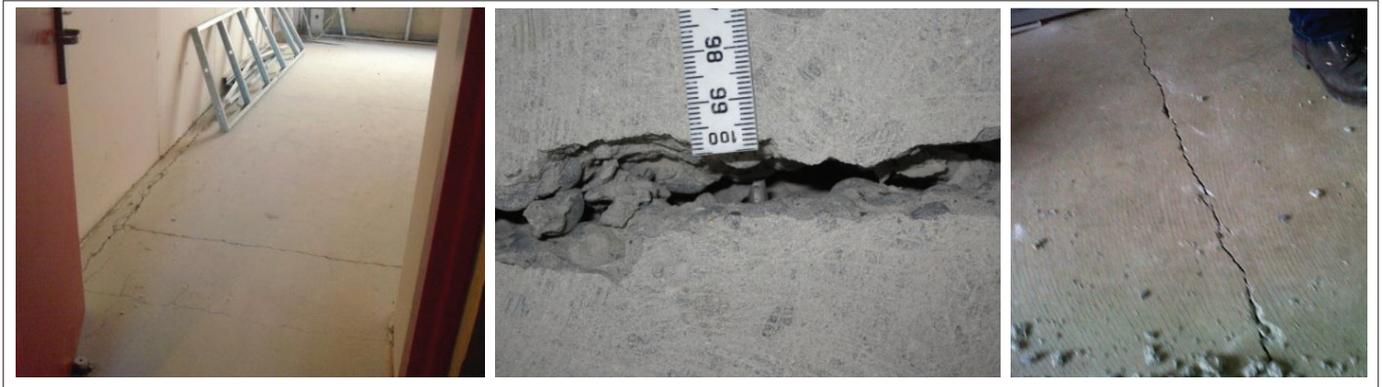
Figure 3: Cracking between individual precast concrete flooring units and mesh rupture observed following the 2011 Christchurch earthquakes (Henry and Ingham 2012)

were observed between individual precast flooring units, providing evidence of diaphragm degradation out in the floor span. Across these cracks it was commonly observed that the floor reinforcing mesh had ruptured, leading to the loss of the tension tie component of the diaphragm load path. Examples of this form of diaphragm damage are displayed in Figure 3.

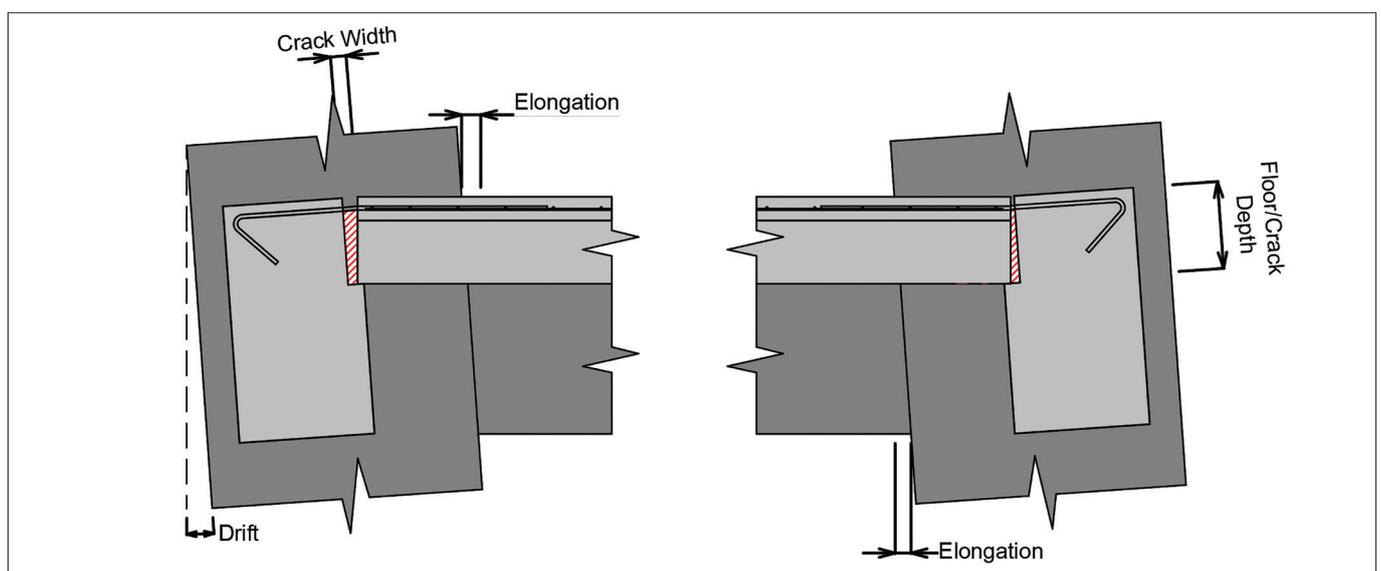
Figure 4: Loss of diaphragm load-path under uni-directional loading

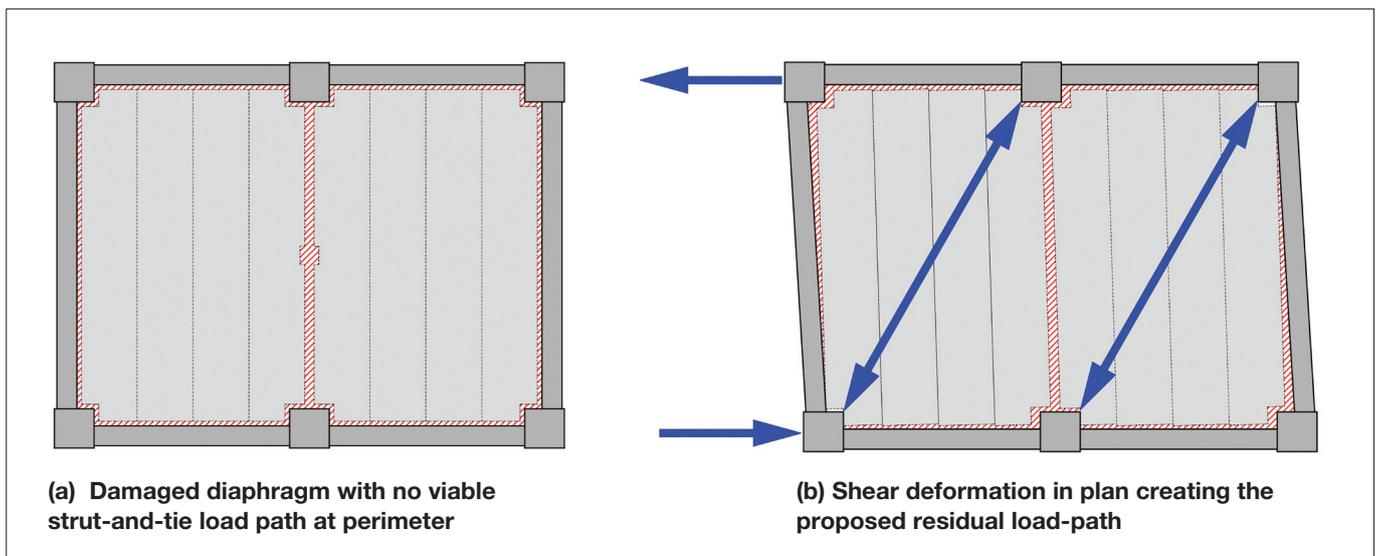
Figure 5: Proposed residual diaphragm load path – shear deformation in plan creating the “picture frame effect”

The second assumption is that the frame does not maintain its shape as the diaphragm degrades, but instead warps in plan. As perimeter cracks become very wide it is likely that simultaneous bidirectional loading would not cause binding of the diaphragm and load transfer between frame elements. However, at this stage of damage the frames would not be linked and therefore would be deforming independently of one another. This would create torsional and warping deformation of the entire structure in plan. Evidence of this kind of structural behaviour was provided in recent shake table testing in Taiwan (Suzuki et al. 2020). If the surrounding frame elements of the floor were to warp into a rhomboidal shape in plan, this could create an intermittent strut from the floor wedging across the diagonals between columns of the warped frame as displayed in Figure 5.

In other words, if the frame undergoes shear deformation in plan, this could wedge the floor and instate a residual load transfer mechanism to link the frames. For pseudo-static testing this would require manually enforcing the shear deformation in plan by moving one frame with hydraulic actuators while keeping the other fixed in the manner shown in Figure 5.

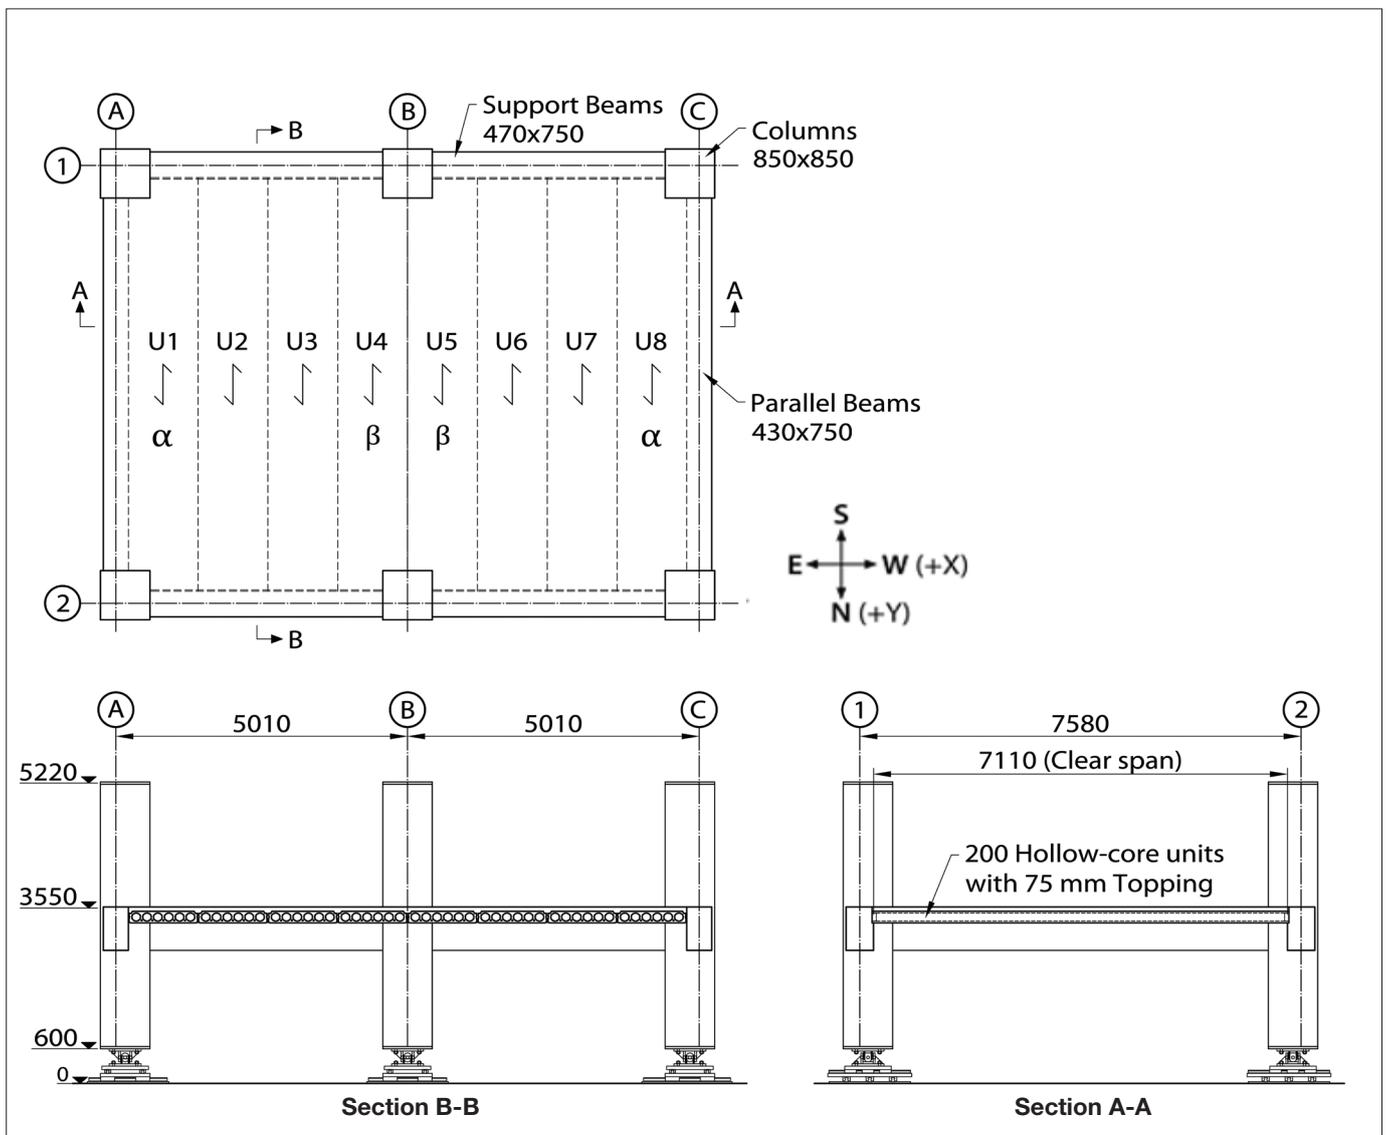
Figure 6: 2020 UC super-assembly experiment frame layout and nominal dimensions (Büker et al. 2022)

As detailed in a companion paper (Büker et al. 2022) the two super-assembly experiments conducted at the University of Canterbury (UFC) during 2020 and 2021 (Fig 8) were designed to provide realistic deformation incompatibility demands under lateral loading into a hollow core floor system via a support frame based on a subsection of a typical ductile reinforced concrete moment frame building. The two experiments used the same frame and hollow-core layout shown in Figure 6.

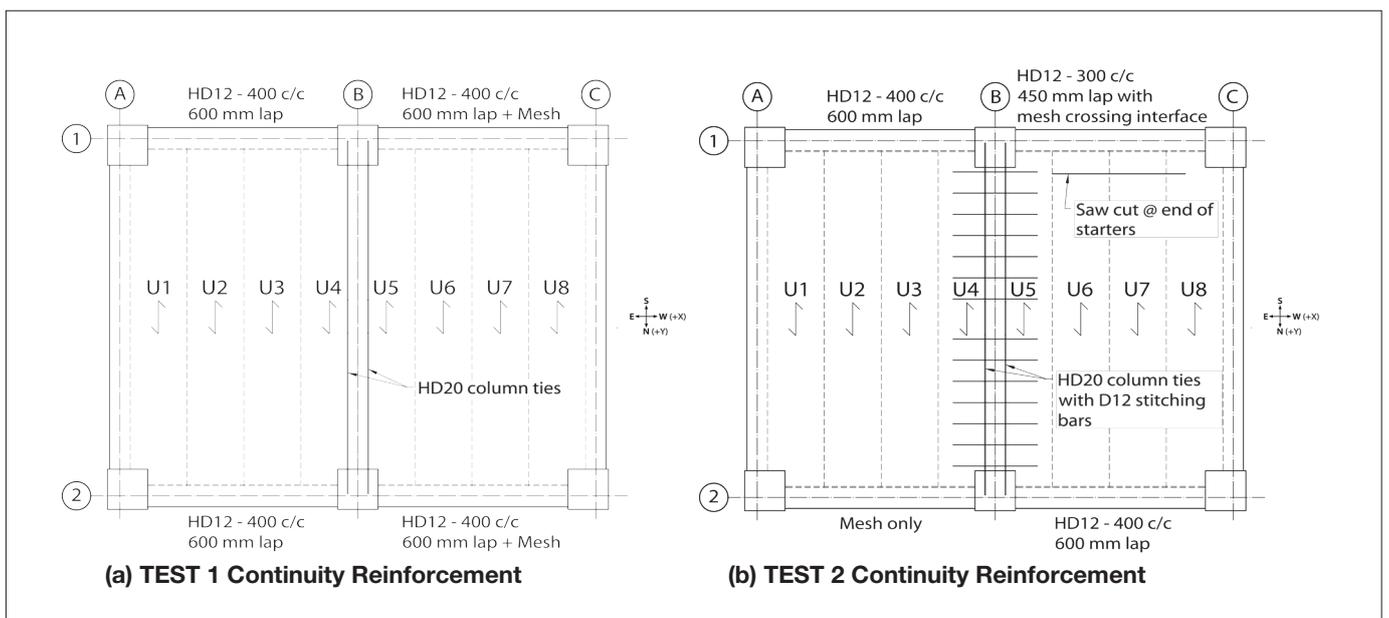
Figure 7: Floor continuity reinforcement arrangements for TEST 1 and TEST 2 (Büker et al. 2022)

beams and a linearized circular loading protocol with 1:1 directionality of loading for the standard loading protocol. The first bay of the specimen had no mesh crossing the beam-floor interface. The second bay did have mesh crossing the beam-floor interface to observe the effects of a stronger connection on the hollow-core units, which had been retrofitted against negative moment failure. The layout of this experiment is displayed in Figure 7 (a) and will be referred to in this report as TEST 1.

The second super-assembly experiment used different starter bar configurations at the four support ends of the two bays to encourage targeted local hollow-core failure modes to initiate at the critical end. In the first (eastern) bay, the northern end of the hollow-core units was designed as critical end for failure, targeting loss of seating with a weak mesh-only beam-floor interface. In the second (western) bay, the southern end of the hollow-core units was designed as the critical end for failure, targeting negative and positive moment failures at the end of the starter bars with high strength beam-floor continuity reinforcement. The targeted critical failure ends of each bay were installed on the diagonals opposite each other to minimise interaction of failure modes that could affect results. Additionally, D12 “stitching” bars were installed linking the two beta units (unit 4 and unit 5) to strengthen the connection after results from the TEST 1 experiment determined that this was a critical weak point for both the gravity carrying and diaphragm functions of the floor. The layout of this experiment is displayed in Figure 7 (b) and will be referred to in this report as TEST 2.

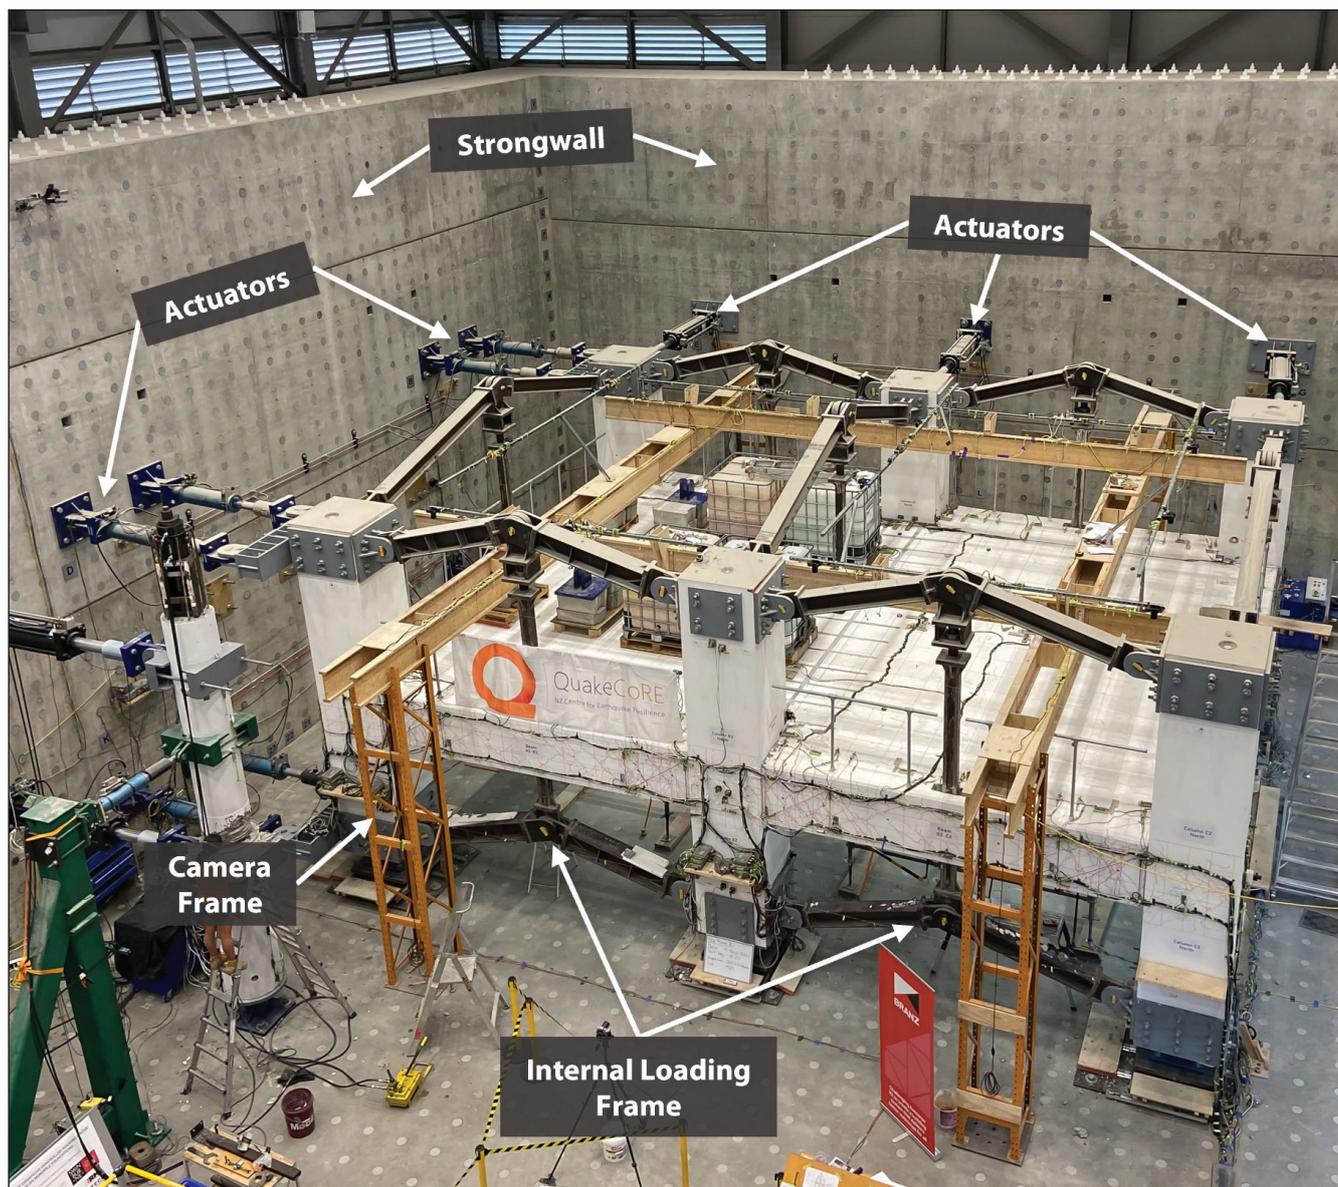
Figure 8: Experimental layout of the 2020 University of Canterbury super-assembly experiments (Büker et al. 2022)

Displacement demands were applied to the specimen using an arrangement of fourteen hydraulic actuators pushing and pulling from a strong-wall as shown in Figure 8.

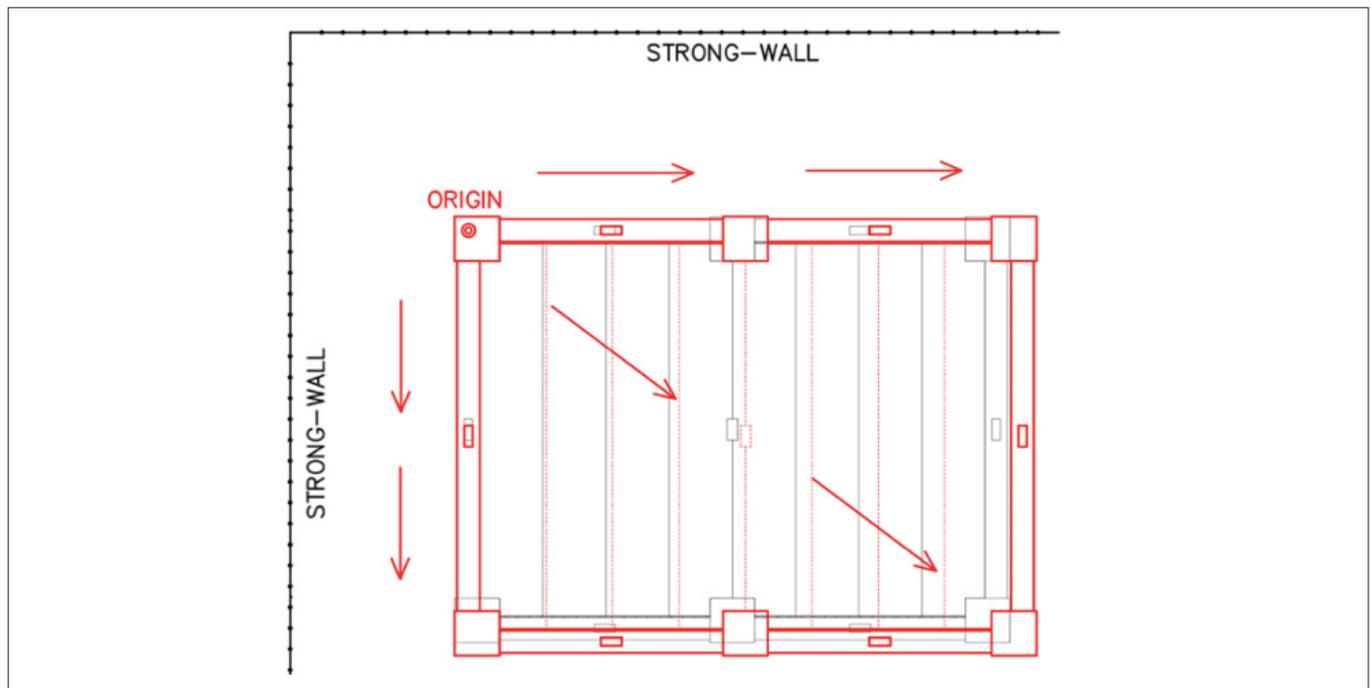
Figure 9: Specimen growth from the origin at column A1 due to beam elongation

The control software for the actuators was programmed to allow the structure to grow from beam-elongation outward from the origin at column A1 depicted in Figure 9. The concept of how the arrow-frame and bi-directional sliders also facilitated this structural growth is shown in Figure 10. Further details on the design philosophy of the experiment can be found in the thesis (Parr 2022).

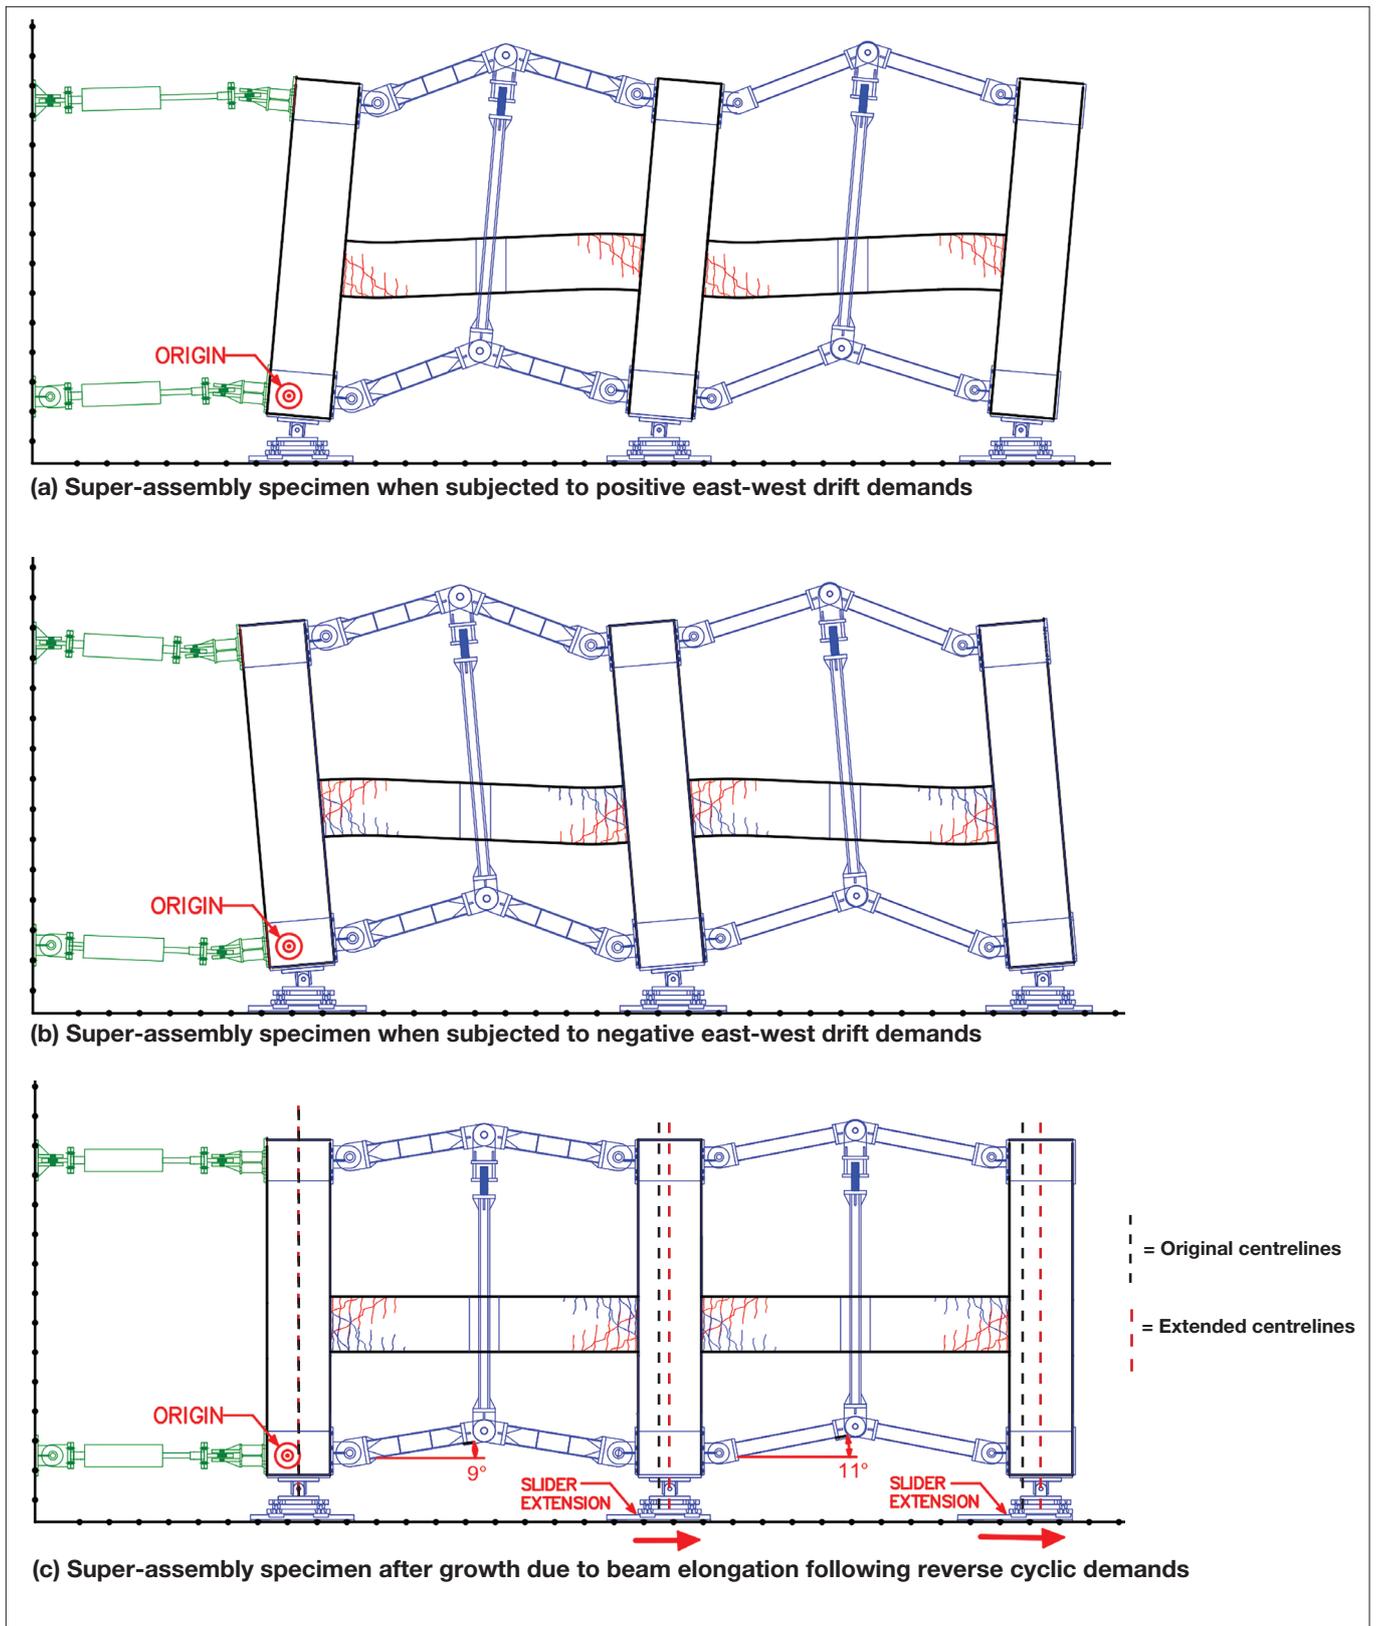
Figure 10: Loading frame system allowing for specimen growth without restraining or promoting beam elongation in the 2020 UC super assembly experiments

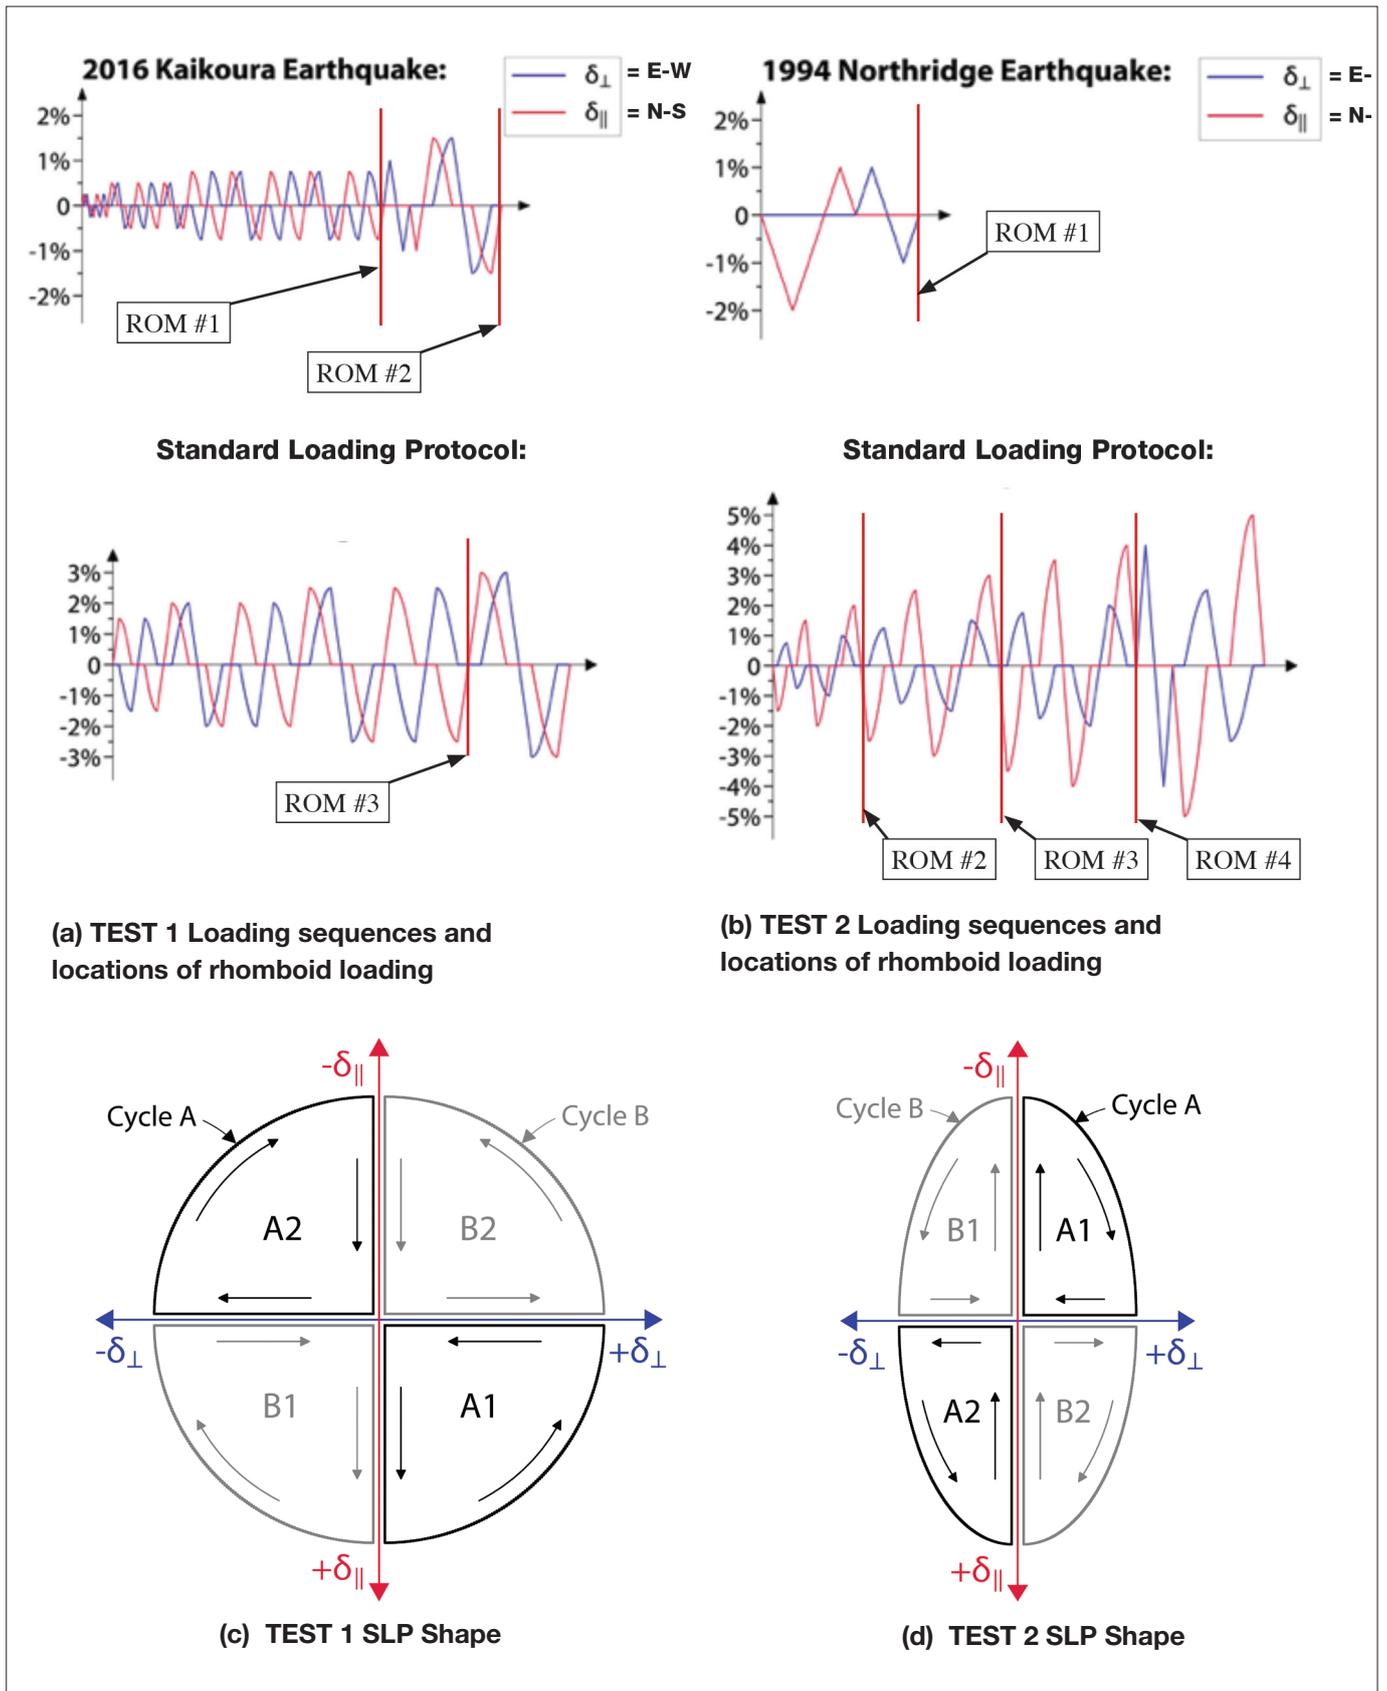
Figure 11: Standard loading protocols and locations of rhomboid loading protocols for the TEST 1 and TEST 2 experiments (Büker et al. 2022)

TEST 1 began with an approximation of the 2016 Kaikoura Earthquake drift cycles for the prototype Wellington building the specimen was based on to allow comparisons to damage modes observed in real buildings. A standard circular loading protocol of increasing drift demands was then applied as shown in Figure 11 (a). TEST 2 started with an approximation of the 1994 Northridge Earthquake to simulate a pulse style loading followed by a standard oval loading protocol of increasing drift demands as displayed in Figure 11 (d).

At selected locations within the TEST 1 and TEST 2 loading protocols, the loading was switched to a rhomboid loading protocol to enforce plan shear distortion into the floor diaphragm and assess the diaphragm load paths. The locations where the standard loading protocols (SLP's) were stopped for rhomboid loading in TEST 1 and TEST 2 are displayed in Figure 11 (a) and (b).

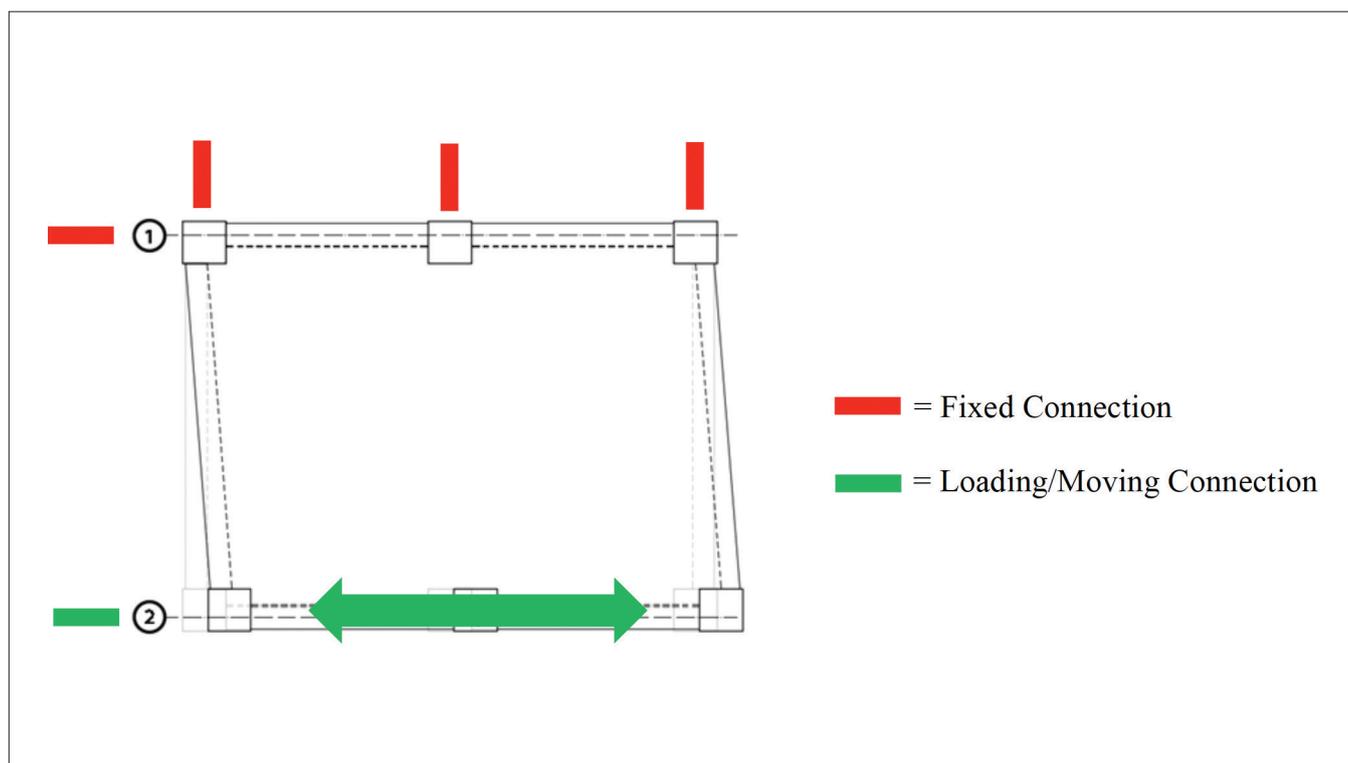
Figure 12: Fixity and loading of the specimen during rhomboid loading (positive shear distortion shown)

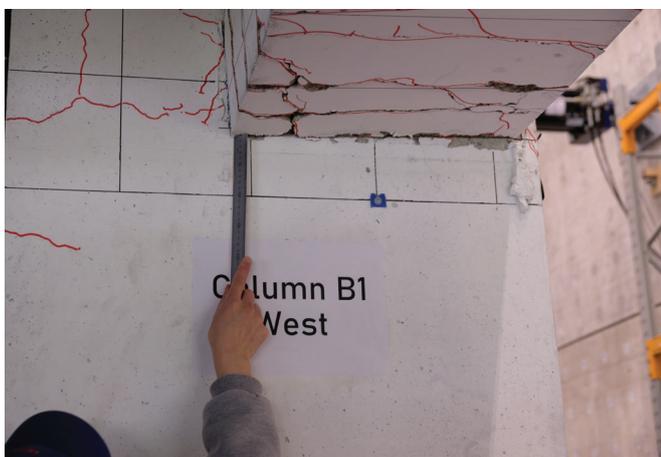
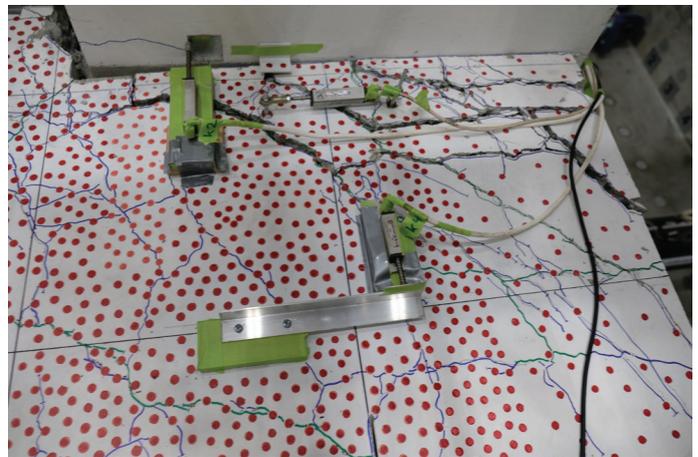
Figure 13: Significant beam torsion visible at the conclusion of the TEST 1

loading at 1.5% drift. From this point on, the two bays of the specimen acted as separate floor plates. There were early signs of cracks developing in the floorplate at the ends of starter bars up to approximately 1.5% drift, but in future cycles, these cracks were observed closing compared to previous cycles. The closing up of inner floor cracks coincided with observations that the beams were beginning to rotate torsionally into the structure. Development of additional significant cracking relevant to diaphragm performance from this stage was limited to the topping located near plastic hinge zones of the beams, particularly in the corners of the overall floorplate where seating of the alpha units was located. An example of significant beam torsion observed at the end of the TEST 1 test in a support beam is displayed in Figure 13. Note that the black lines drawn near the bottom corners of the beam aligned with the original location of the beam face.

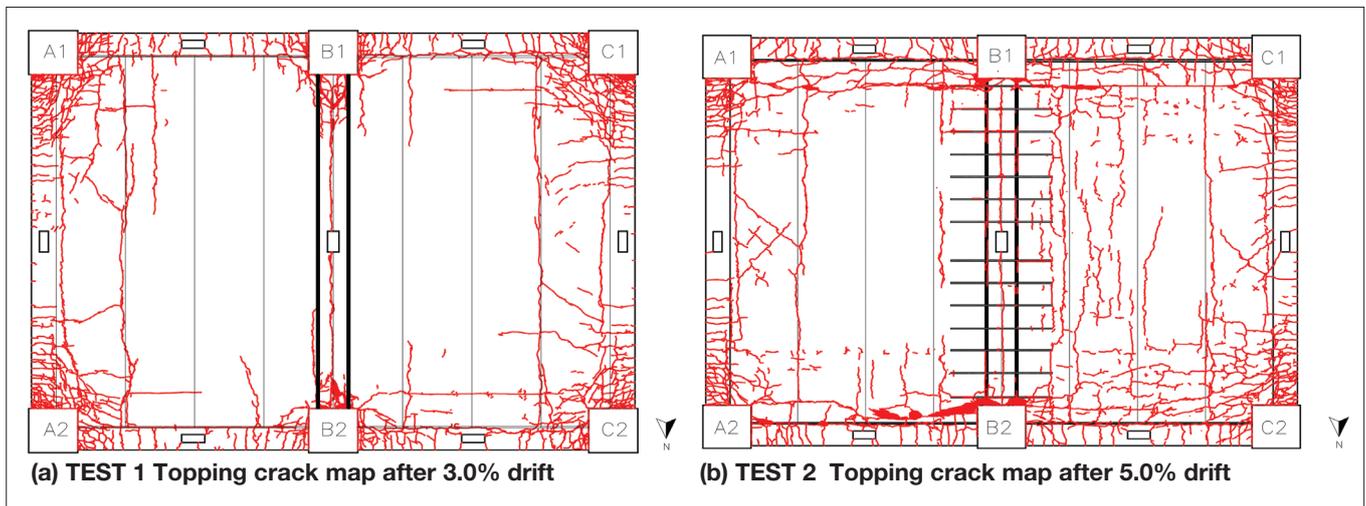
Figure 14: Topping crack maps for TEST 1 and TEST 2 at conclusion of experiments

The crack patterns recorded at the end of TEST 1 and TEST 2 are displayed in Figure 14, depicting the different damage modes observed between them. Hairline cracks and cracks that closed following primary damage modes forming are removed in Figure 15 to allow for easier comparison of the primary damage modes.

Note that the primary floor cracking damage in TEST 1 ran in the north-south direction, the primary example being the split between the two beta units which caused the two bays to act independently from 1.5% drift onwards. Other than this major crack most damage was contained to areas near the beam plastic hinge zones. In TEST 2 the primary floor cracking damage ran in the east-west direction, at the end of the starter bars on the south end and at the beam-floor interface on the north end. This was due to the stitching bar retrofit strengthening the beta-beta unit interface and the directionality of loading being more critical in the north-south direction compared to TEST 1.

In both the TEST 1 and TEST 2 experiments, similar behaviour was observed with unit-unit interactions. As seen by the crack patterns displayed in Figure 14 and Figure 15, the intra-span units (units within the span, i.e. not alpha or beta units) and beta units acted as a single block rather than in a shear “racking” fashion that would have created significant cracking between each individual unit. Significant inter-unit cracking triggered in weak points within or adjacent to the alpha units and between or adjacent to the beta units. Once significant cracking was triggered at these weak points, additional damage concentrated at them instead of distributing between other unit interfaces. A likely cause for the ability of the intra-span units to act as a single element without significant damage was the relative flexibility of the beams once they began to twist. Warping and rotation of the beam plastic hinges was where deformation incompatibility demands between the intra-span units and support beams concentrated.

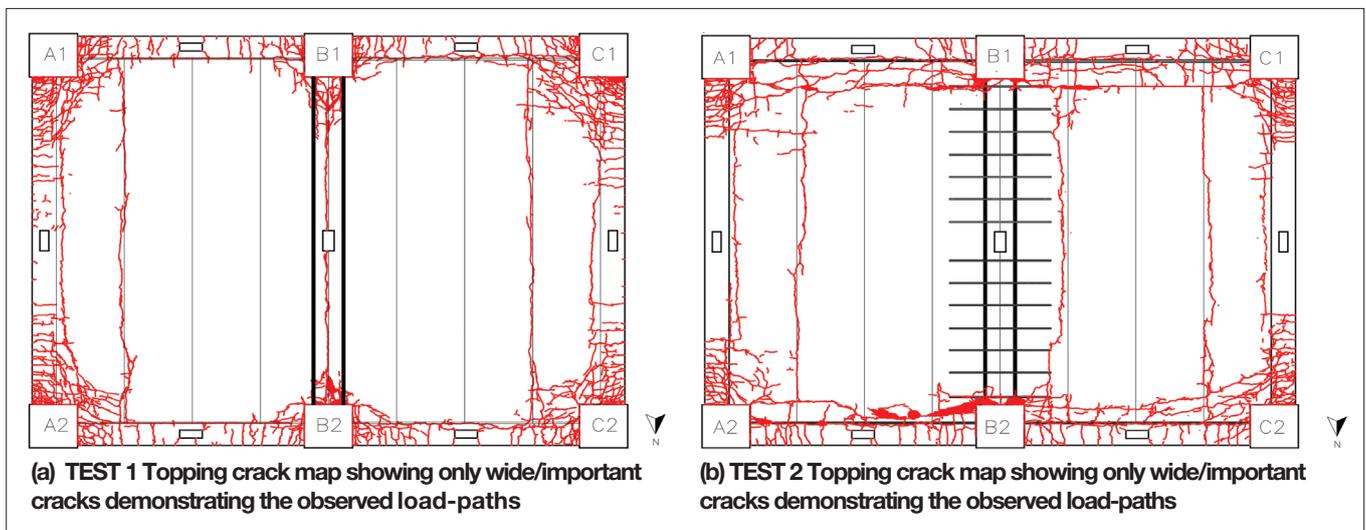
Figure 15: Topping crack maps for TEST 1 and TEST 2 at conclusion of tests with only critical wide cracks impacting load-paths visible

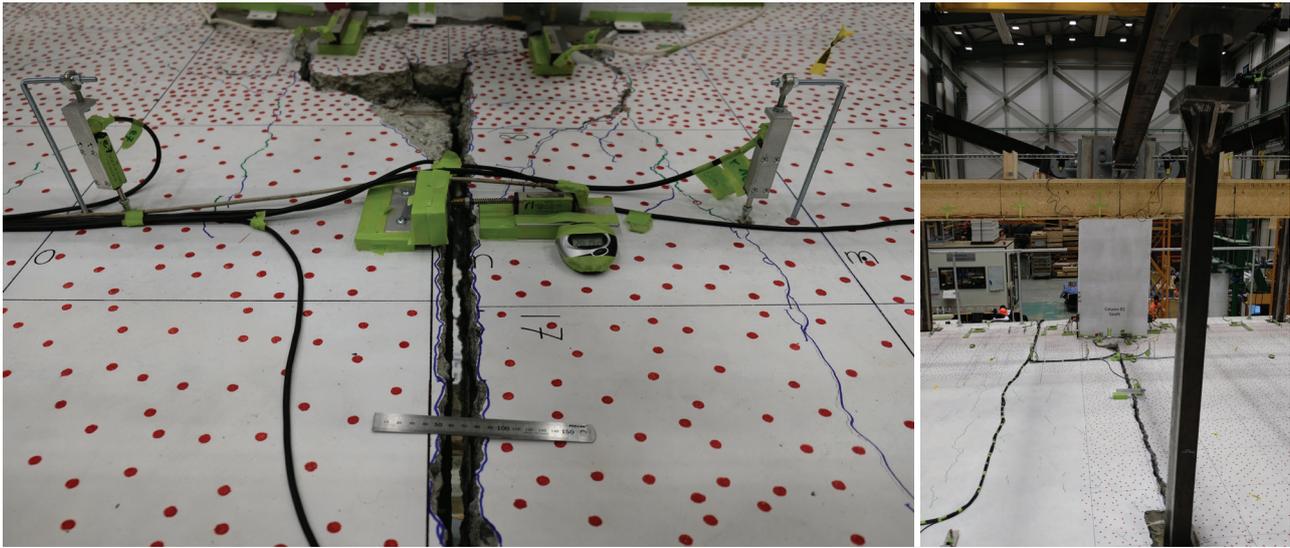
(a) TEST 1 Beta-beta unit interface crack following 3.0% drift demands

Figure 16: Comparison of inter-unit cracking near the beta units between the TEST 1 and TEST 2 experiments

The TEST 1 specimen developed a full-length split between the beta-beta unit interface at 0.25% drift. Further damage concentrated at this split in later cycles with mesh rupture along the interface occurring in the first arc

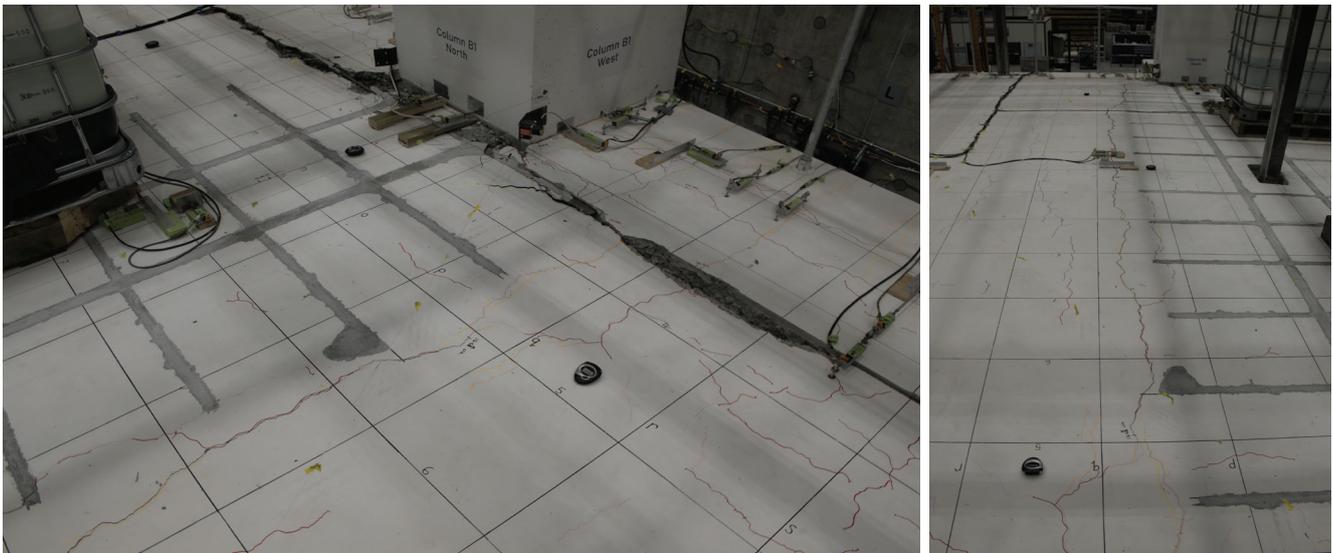
(b) TEST 2 Unit 5 – Unit 6 crack (only developed under large shear distortion demands after 4.0% drift)

The stitching bars succeeded in preventing significant cracking developing between the two beta units, with a maximum beta-beta unit crack width recorded of approximately 0.2 mm. Instead multiple smaller cracks developed along and between units. As there was no mesh rupture or wide cracks this meant diaphragm actions could

develop across both bays. This was the case until the 4th rhomboid when significant shear distortion in the positive direction (at a γ value between 0.23% and 0.25%) caused a large split to occur between unit 5 and unit 6 near the end of the stitching bar retrofit.

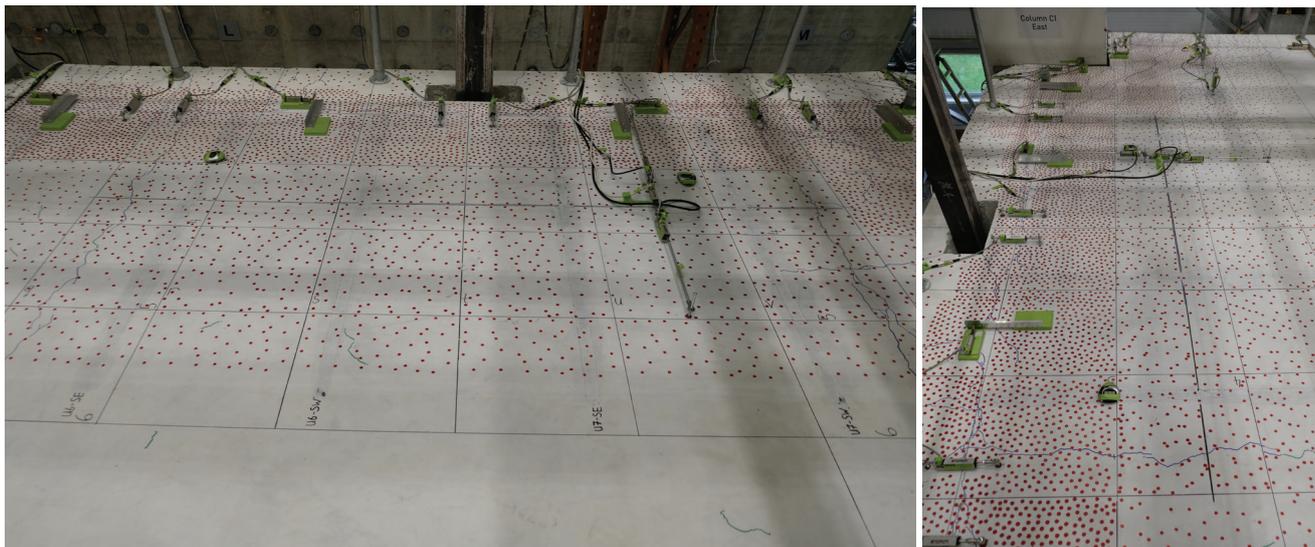
(a) TEST 1 End of starter bar cracks following 3.0% drift demand

Figure 17: Comparison of cracking at the end of starter bars on the south end of the floor between the TEST 1 and TEST 2 experiments

A comparison between the TEST 1 and TEST 2 experiments of cracking at the end of the starter bars at the south end of the floor near the end of both tests is displayed in Figure 17.

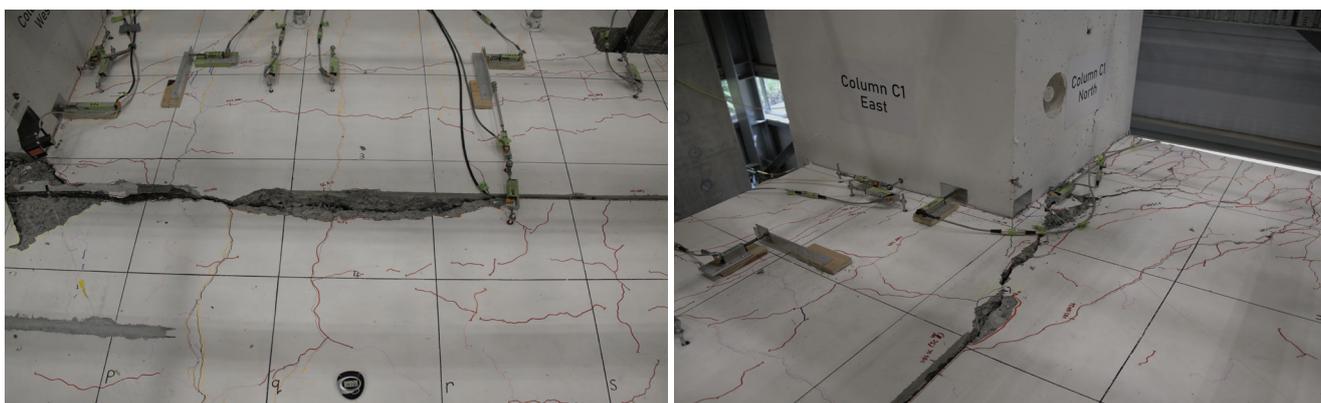
(a) TEST 2 End of starter bar cracks following 4.0% drift demand

The TEST 2 specimen sustained much greater damage at the end of the starter bars compared to the TEST 1 specimen. This was primarily due to the change in directionality of loading protocols with less beam torsional softening observed in TEST 2 due to the reduction of simultaneous demands. An additional factor altering the strength hierarchy of the beam torsional capacity vs floor strength between the two tests was the additional roughening of the cold joint between the column concrete element and beam concrete elements in TEST 2 as described in Section 2. These factors meant the beams remained stiff enough to impart large deformation incompatibility demands into the floor units, leading to significant early cracking.
