LOAD-PATH AND STIFFNESS DEGRADATION OF FLOOR DIAPHRAGMS IN REINFORCED CONCRETE BUILDINGS SUBJECTED TO LATERAL LOADING

PART I: EXPERIMENTAL OBSERVATIONS

Part I of II in this journal series details the full-scale super-assembly experiment conducted on a floor diaphragm at different damage states and the observed behaviour during testing.

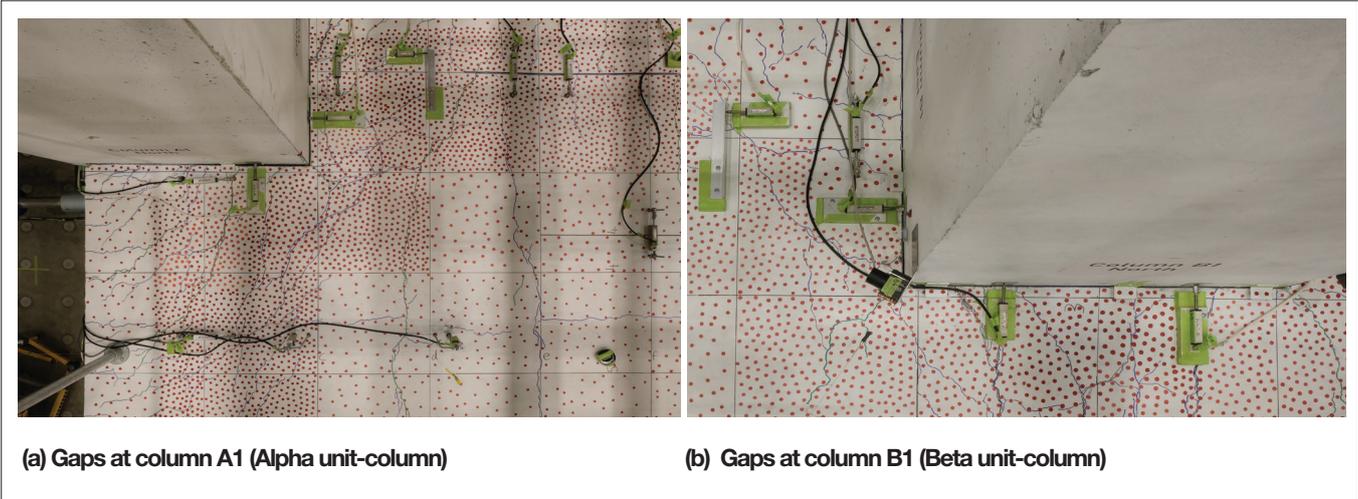
Figure 18: Gaps between the floor and columns at 1% drift in TEST 1

By approximately 1%-1.5% drift in both tests, openings were observed around the entire perimeter of the floor-to-column interfaces, removing any possibility of diaphragm compression struts landing directly into the columns including into the intermediate columns B1 and B2. These openings grew wider with subsequent drift cycles. This means that early in the earthquake record the only remaining diaphragm load path to link the frame elements was through the beams. The only caveat to this general rule was where the tie-bars were anchored into the intermediate columns, though these would not have provided a significant stiff load-path as they were only two D20s acting in compression and dowel action for the purposes of landing compression struts into the columns.

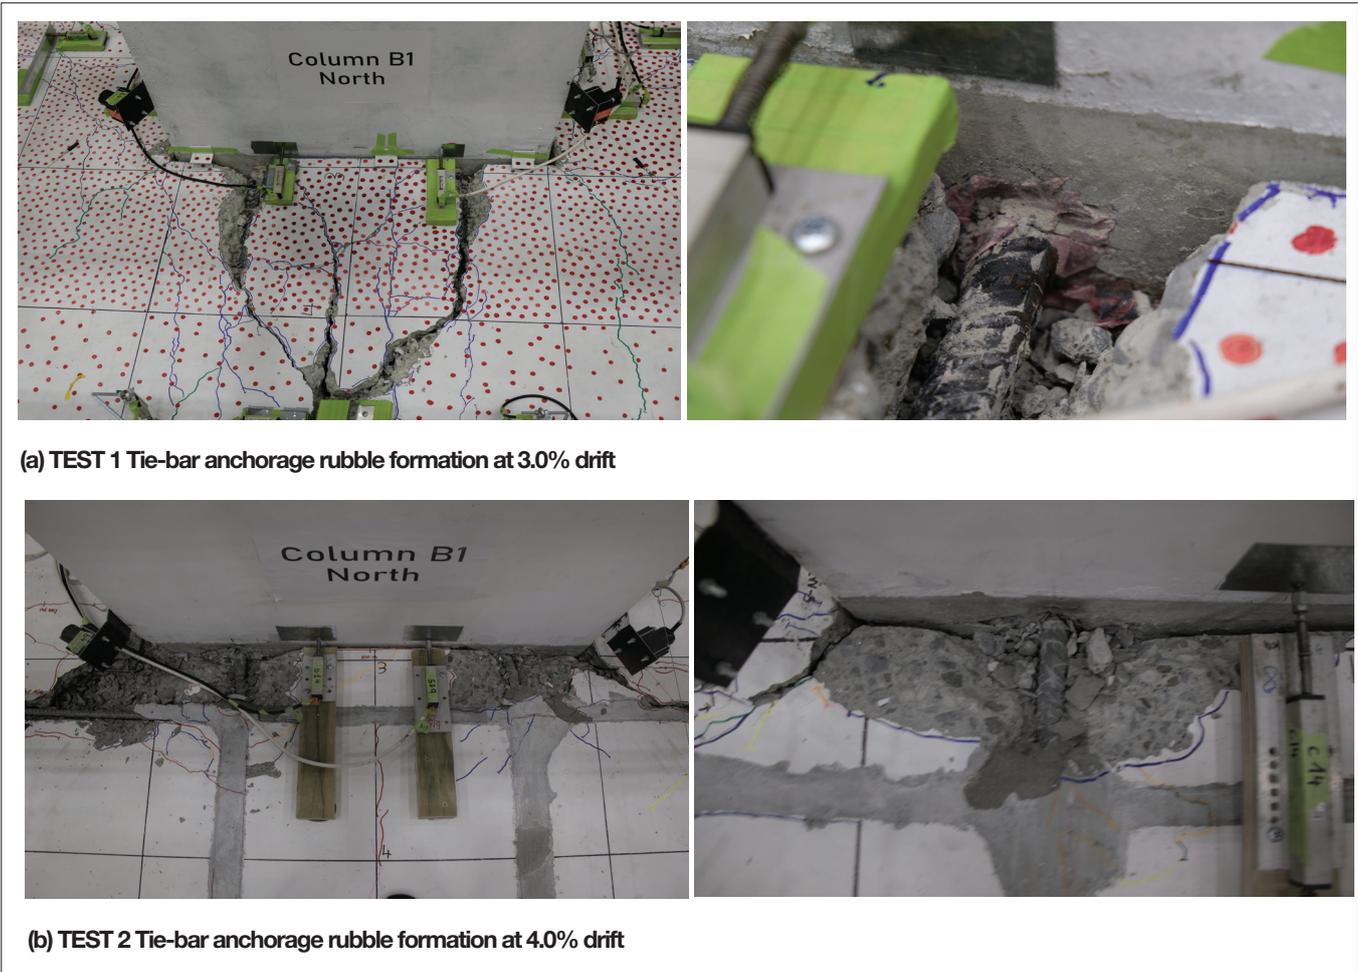
Figure 19: Tie-bar anchorage rubble formation observed in the super-assembly experiments

In both experiments significant cracking and spalling of the topping occurred around the tie-bar connections into the column interface. This made the tie-bars visible at higher drift levels, which were clearly plastically deformed by deformation incompatibility between the beta units and

columns. The cone shaped spalling failures this caused in the nearby concrete through bond stresses are displayed in Figure 19.

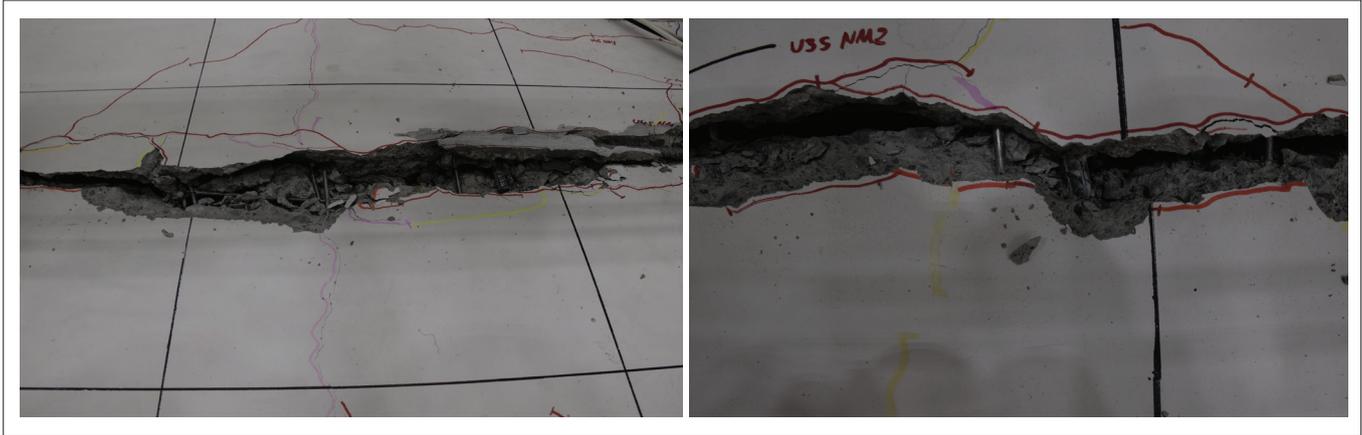
Figure 20: Starter bars and mesh initiating rubble formation within floor cracks

The dislodgement of rubble was particularly noticeable near starter bars. The ends of the starter bar would scrape against the other side of the crack, dislodging pieces of aggregate and dropping them into the crack as shown in Figure 20. In these areas it was not possible to see through the crack and it could be reasonably assumed that rubble became lodged, forming small pathways for compression to be transferred across the crack through contact stresses.

- Contact stresses appear to form across wide concrete cracks in floors due to rubble replenishment. These contact stresses provide a rigid connection resistant to in-plane shear deformation that can allow diaphragm compressive struts to land on beams. Formation of aggregate rubble from local concrete crushing appears to be improved near steel reinforcing, particularly deformed rebar (but also mesh) as depicted in Figure 20 and Figure 26.

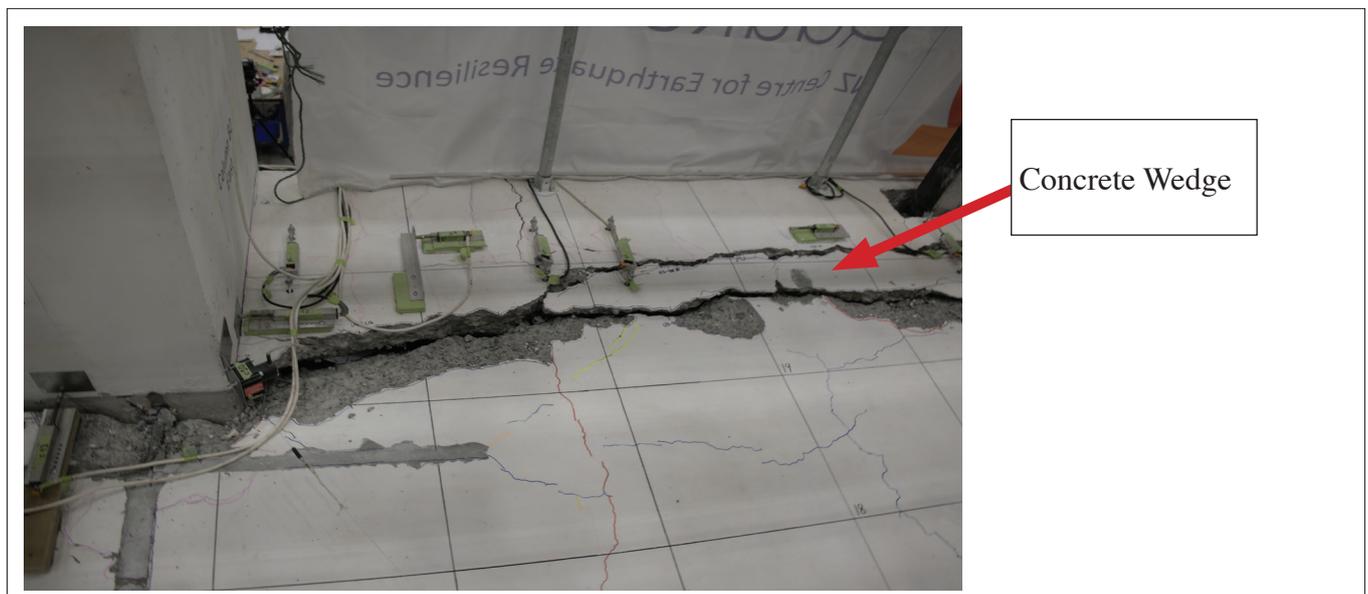
Figure 21: Beam-unit crack interface concrete wedge on east side of column B2 at 4.0% drift

The most obvious case of rubble formation providing a contact stress load-path across a crack occurred on the east side of column B2. A large wedge of concrete became detached from the topping and hollow-core at approximately 2.0% drift as shown in Figure 21.

However it was not possible to remove the detached wedge at any stage of the load protocol until approximately 5.0% drift. Between these drift demands the concrete wedge was under compression, with the wedge slowly being pushed up by the formation of rubble on either side.

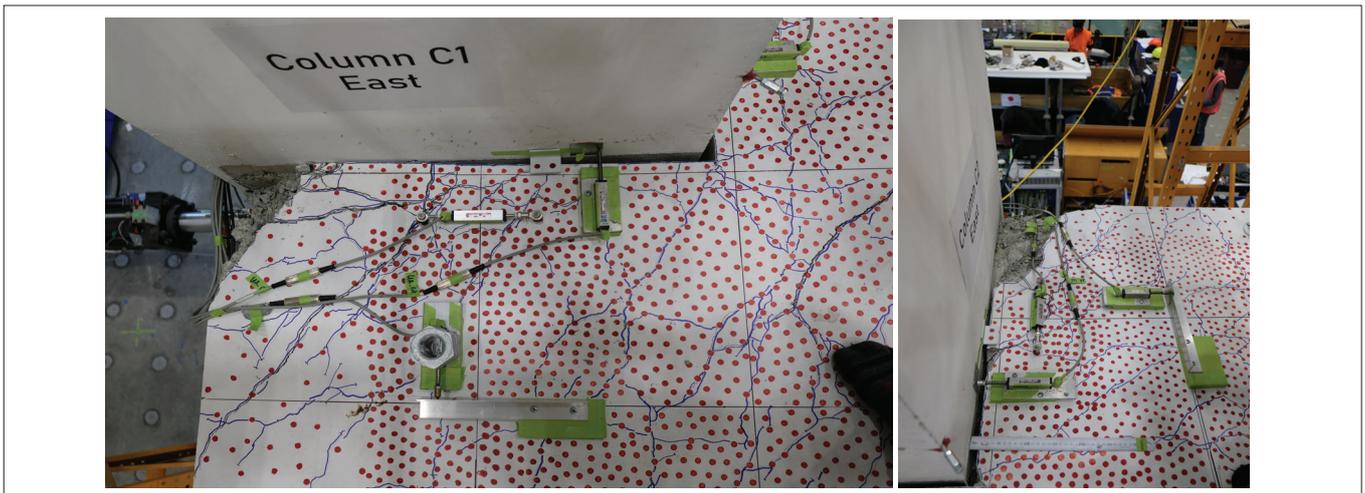
Figure 22: Beam plastic hinge spalling about weak axis from plan shear distortion demands

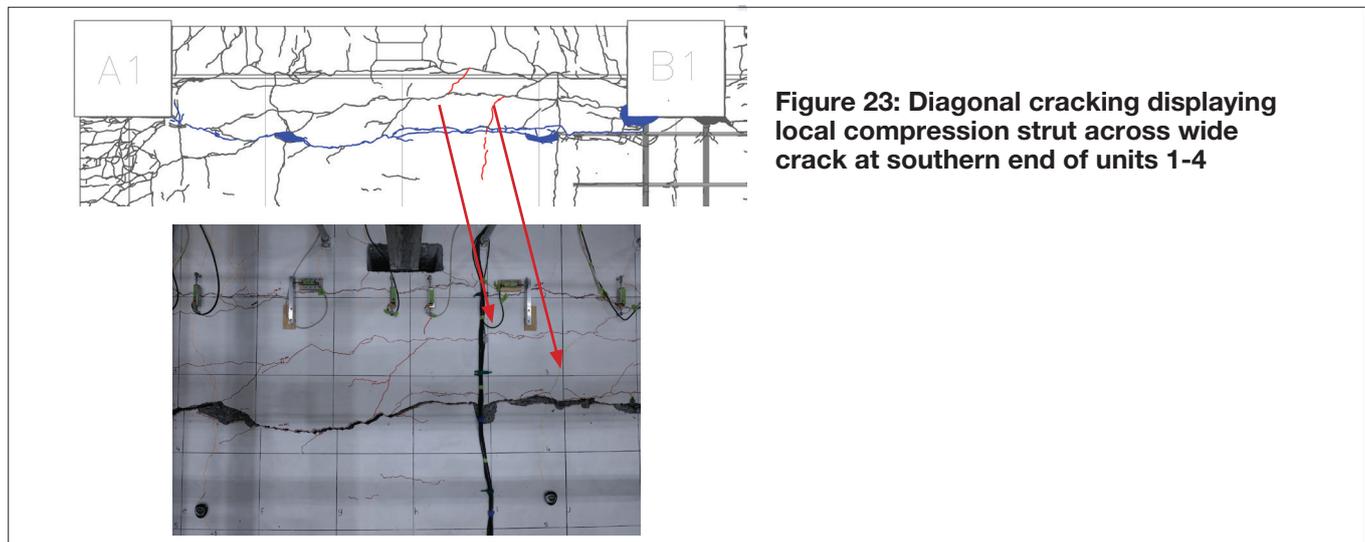
Figure 23: Diagonal cracking displaying local compression strut across wide crack at southern end of units 1-4

The four rhomboid loading protocols conducted in TEST 2 displayed interesting behaviour related to residual compression load-paths across wide cracks. In the 2nd rhomboid, diagonal cracking was observed on the side of a wide crack as shown in Figure 23. This cracking provides evidence of significant local compression across the crack leading to landing of the strut into beam A1B1 towards column B2.

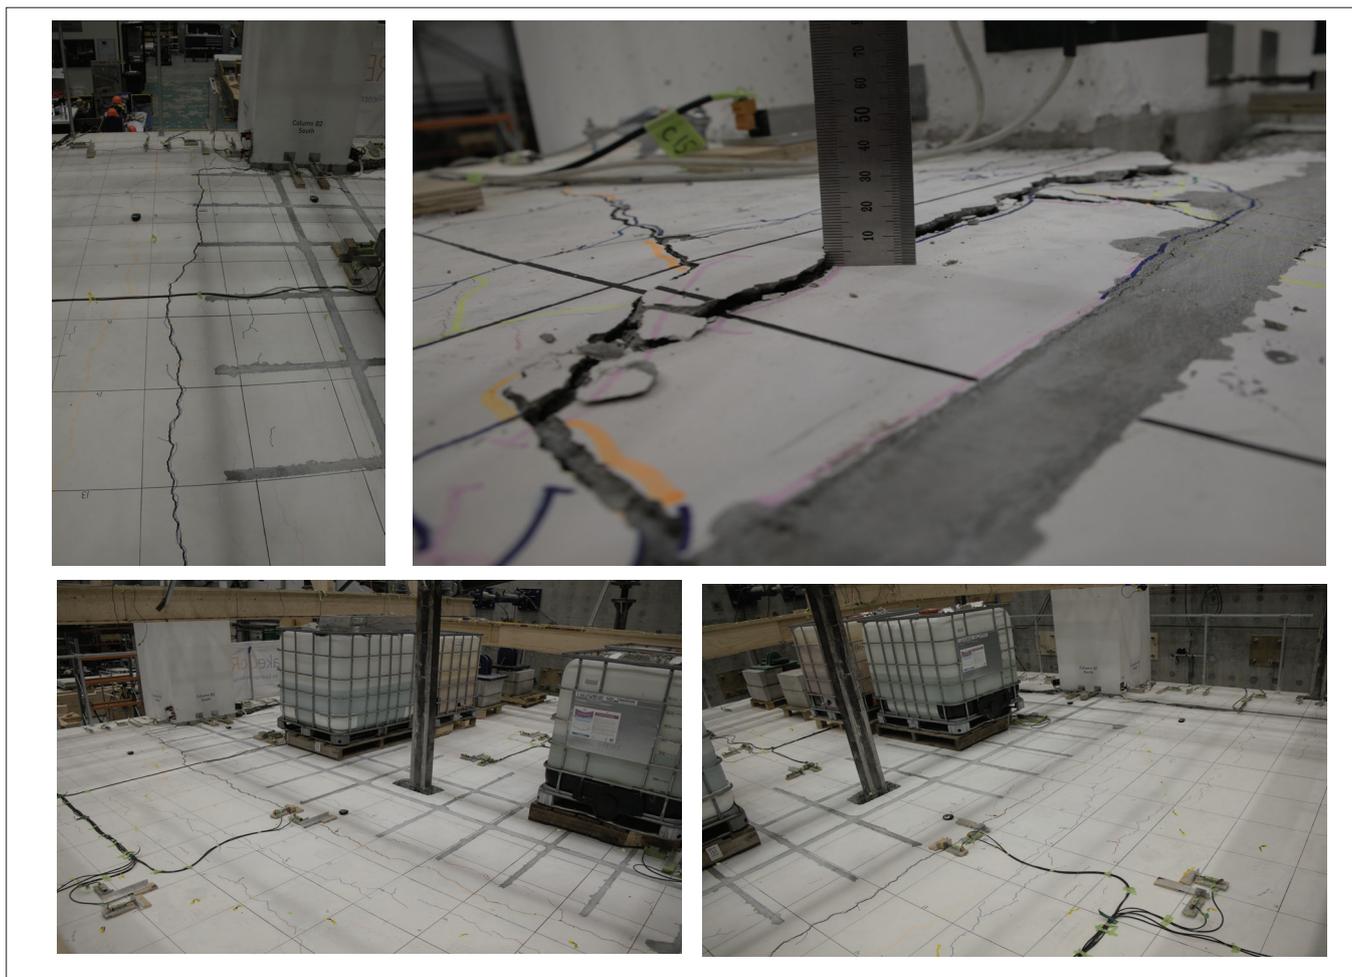
Figure 24: Significant split between Unit 5 and Unit 6 that developed in the TEST 2 4th Rhomboid

damage that developed from this loading was mesh rupture and splitting between unit 5 – unit 6 near the end of the stitching bar retrofit as shown in Figure 24.

This rupture occurred at a shear distortion γ in the positive direction between 0.23% and 0.25%. Mesh rupture was observed along approximately 2/3rds of the length from the north end. The crack was much wider at the north end with a width of approximately 7 mm and 4.5 mm vertical offset (with the beta units dropping). At the south end this reduced to approximately 3 mm with no vertical offset. This shows that at the northern end there were significant tensile forces across the crack due to the diaphragm internal strut-and-tie load-path. This is discussed further in Part II (Parr et al. 2022).

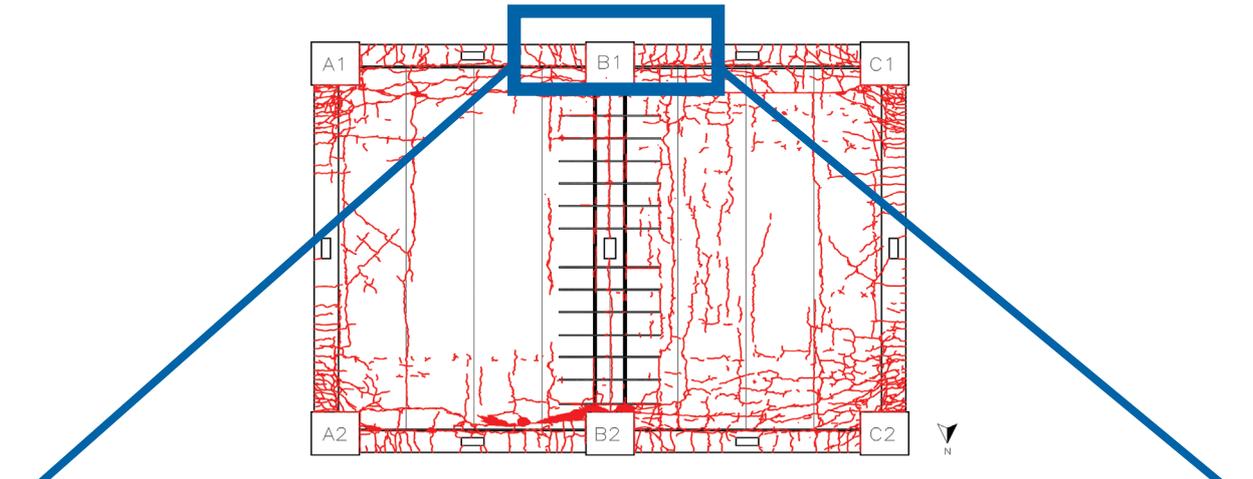
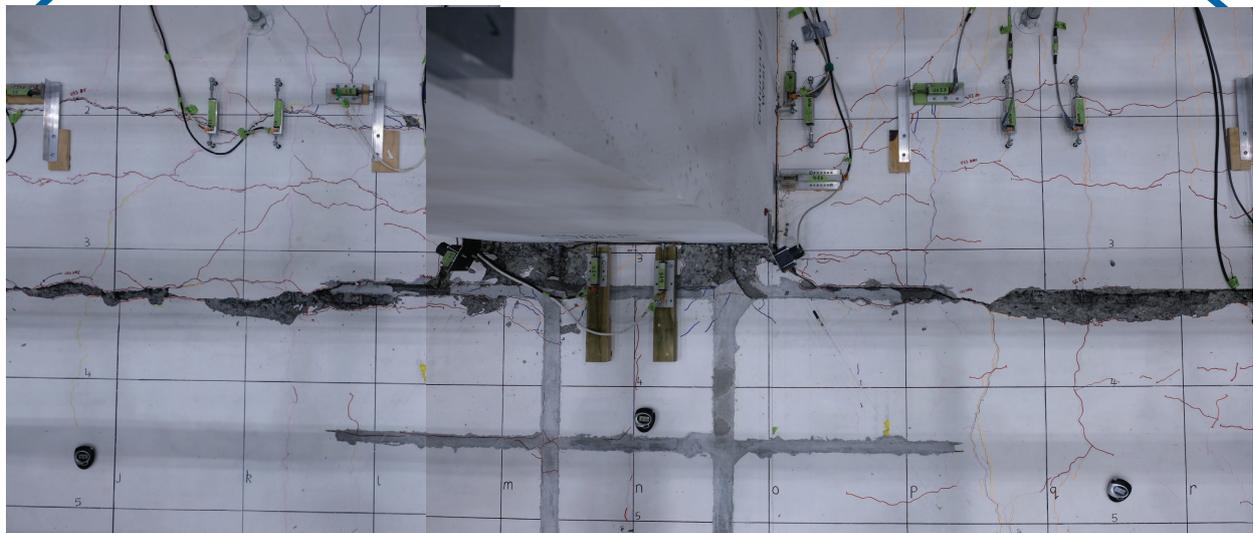
(a) Location on specimen and floor-column interface prior to rhomboid 4 loading

Figure 25: Evidence of compression struts landing directly into the B1 intermediate column at a high damage state due to contact stresses formed by tie-bar anchorage rubble

Additionally in the 4th rhomboid of TEST 2 a residual load-path was observed landing compression struts directly into the column faces of the intermediate columns (B1 and B2). As shown in Figure 25, as a result of loading in the positive direction, a section of the topping near the eastern

tie-bar in column B1 spalled due to crushing failure. Upon observation of the gap between the column and beta unit it was not possible to see through the gap near the tie-bar. This was due to the significant spalling of the topping caused by bond stresses with the deformed tie-bars. The spalled concrete rubble had fallen and wedged between the beta units and interior column face of the intermediate columns. This formed a residual diagonal contact stress compression strut load-path directly from the diaphragm into the column face. Under negative loading similar damage was observed from struts landing into the western tie-bar anchored in column B1. The topping spalling from compression struts landing directly into column B1 is displayed in Figure 25 (b) and (c)

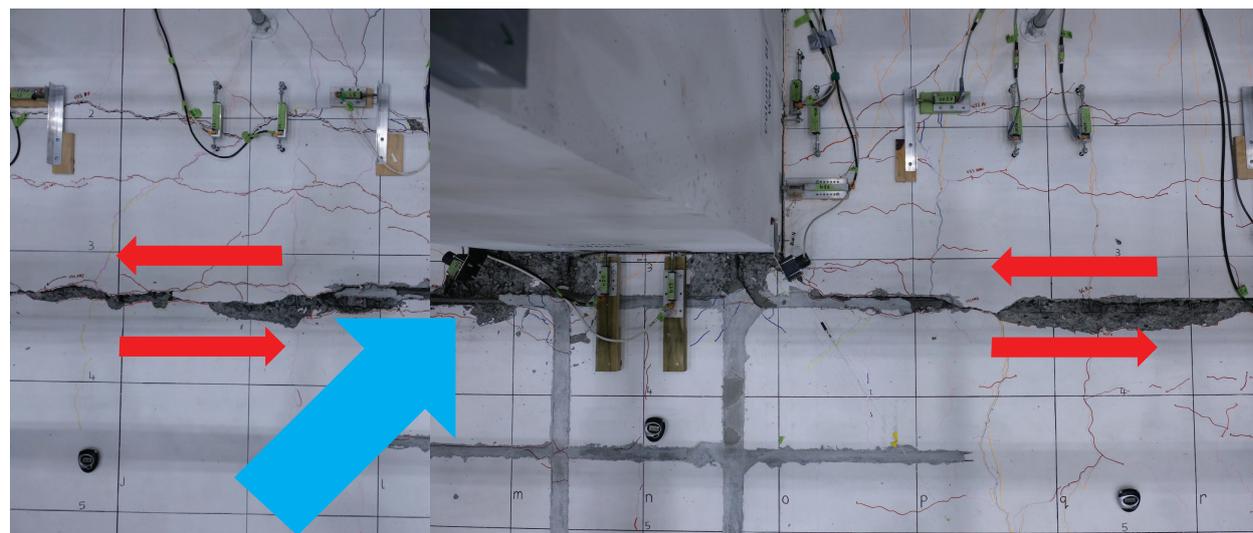
(b) Floor-Column interface with topping spalling at +0.25% floor plan shear distortion

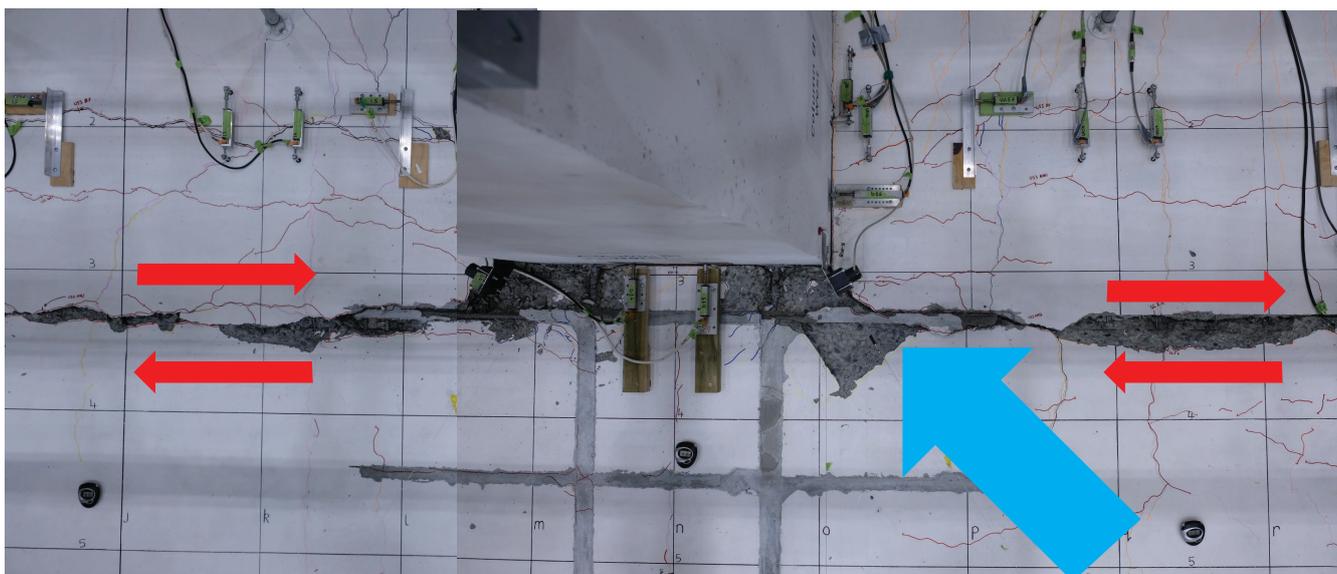
(c) Floor-column interface with topping spalling at -0.25% floor plan shear distortion

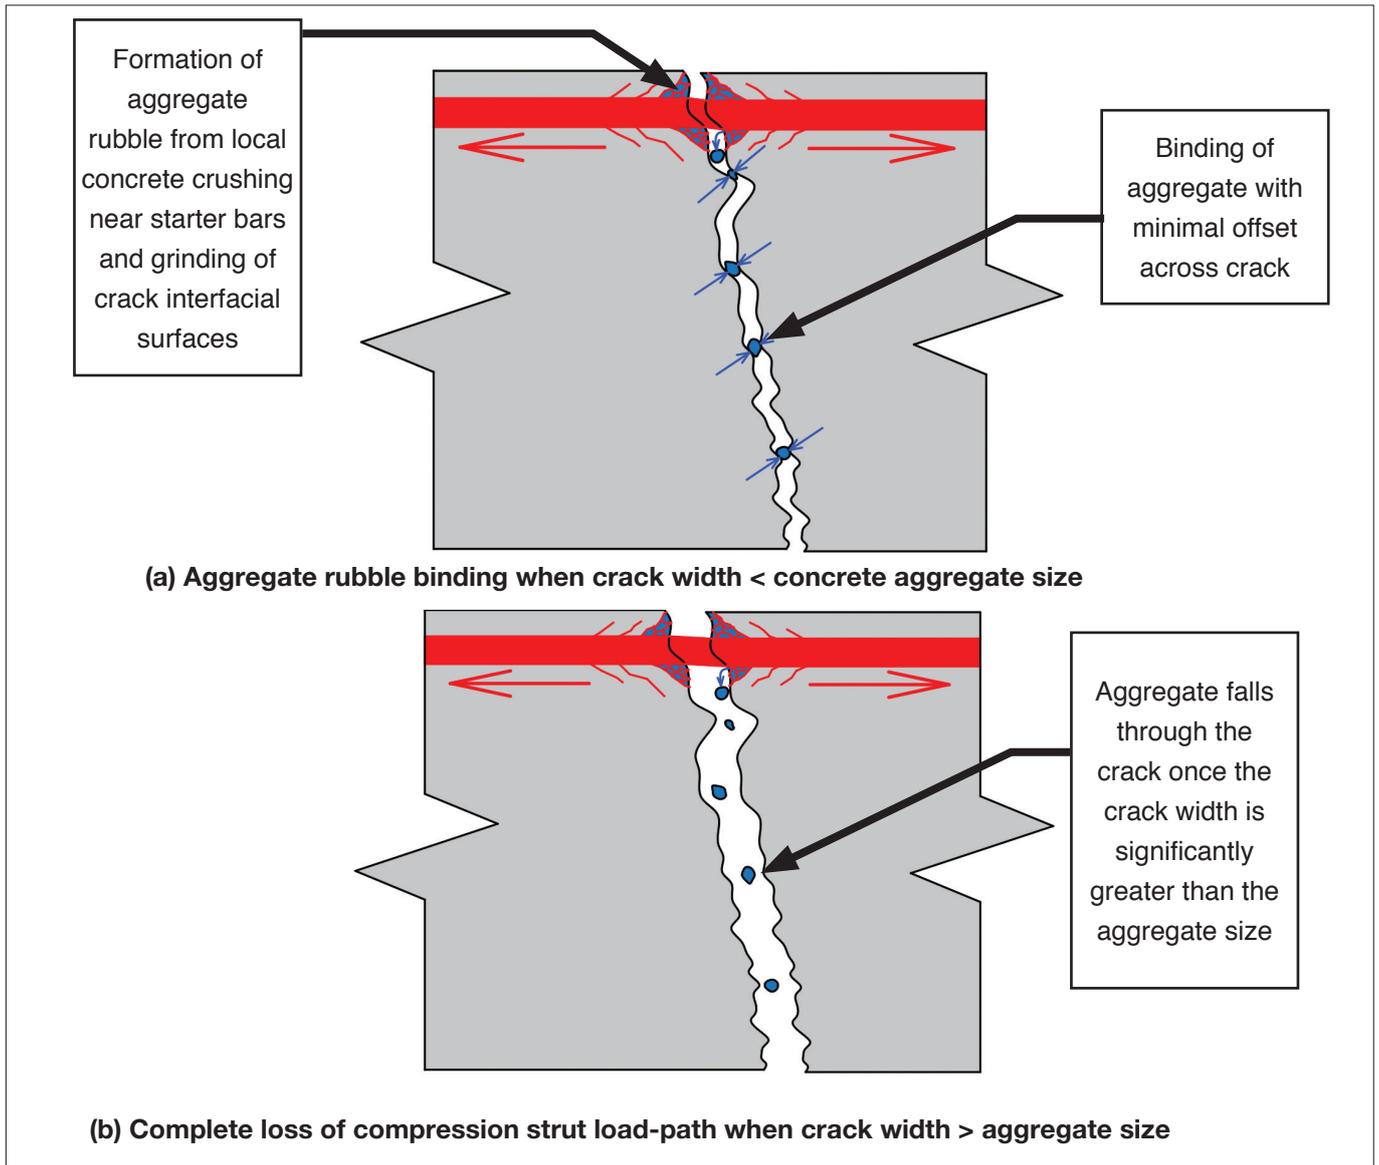
Figure 26: Residual compression strut load-paths forming across wide cracks due to aggregate rubble binding
