SEISMIC PERFORMANCE OF PRECAST HOLLOW-CORE FLOORS WITH MODERN DETAILING: A CASE STUDY

ABSTRACT

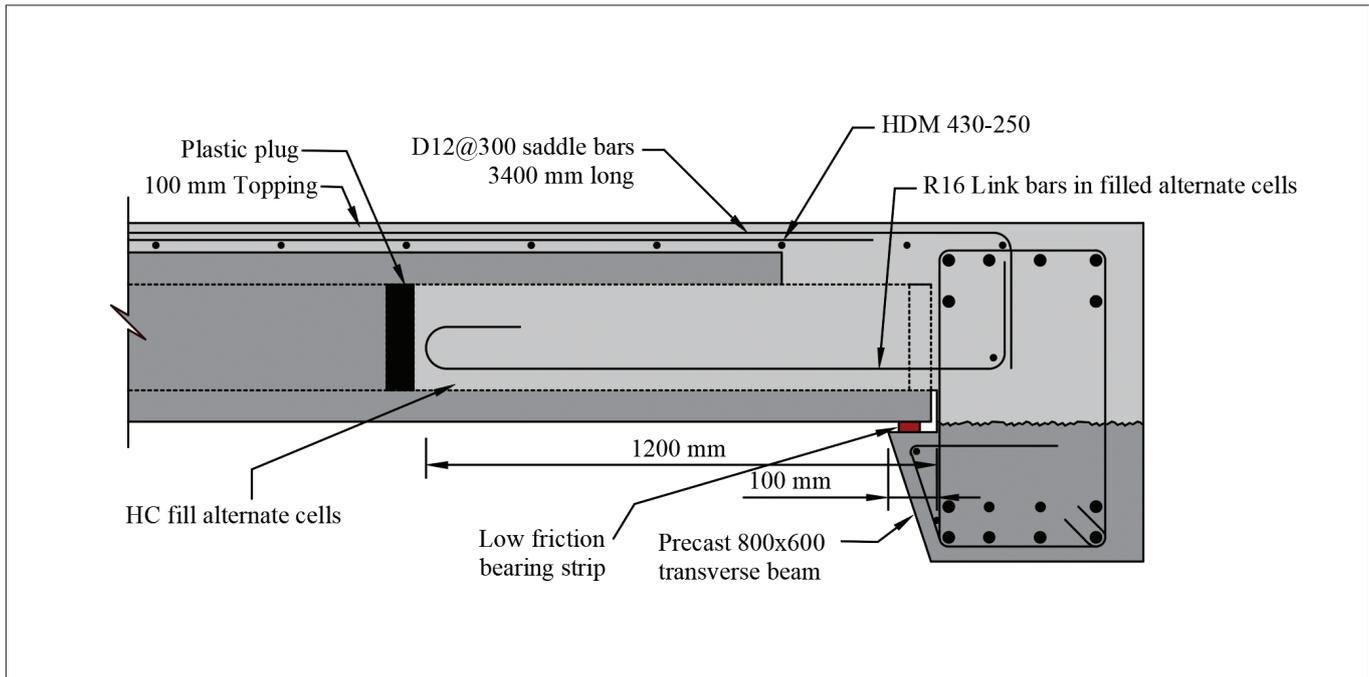
Figure 2: Schematic of floor to beam connection detail (dark grey colour indicates precast portion)

reinforced with ductile mesh (HDM-430-300). Figure 2 shows a typical floor connection detail. The connection detail used in the building was consistent with C18.6.6(e) of NZS3101:2006-A3, which is referenced within clause 3.1.1 of B1/VM1 (MBIE 2021) and hence can be considered a deemed-to-comply solution meeting the performance objectives of the Building Code. The hollow-core units had 100 mm specified seating length with a 50 mm wide low friction bearing strip. Every second cell of the unit was filled, and a 16 mm plain round bar was cast in these filled cells and tied back to the supporting beam. In-situ “link slabs” were used to accommodate deformation incompatibilities between the floor and frame in locations where hollow-core slabs run parallel to multiple-bay frames.

- The seating detail (Figure 2) is consistent with C18.6.7(e) of NZS3101:2006-A3, which is referenced within clause 3.1.1 of B1/VM1, and hence, can be considered a deemed-to-comply solution meeting the performance objectives of the Building Code. However, the damage reported above suggests that this detail does not result in performance consistent with the life safety and amenity performance objectives of the Building Code.
