# **Guidance on Detailed Engineering Evaluation of Earthquake Affected Non-residential Buildings in Canterbury**

## **Part 2 Evaluation Procedure**

Draft Prepared by the Engineering Advisory Group

**Revision 7, tba 2012**

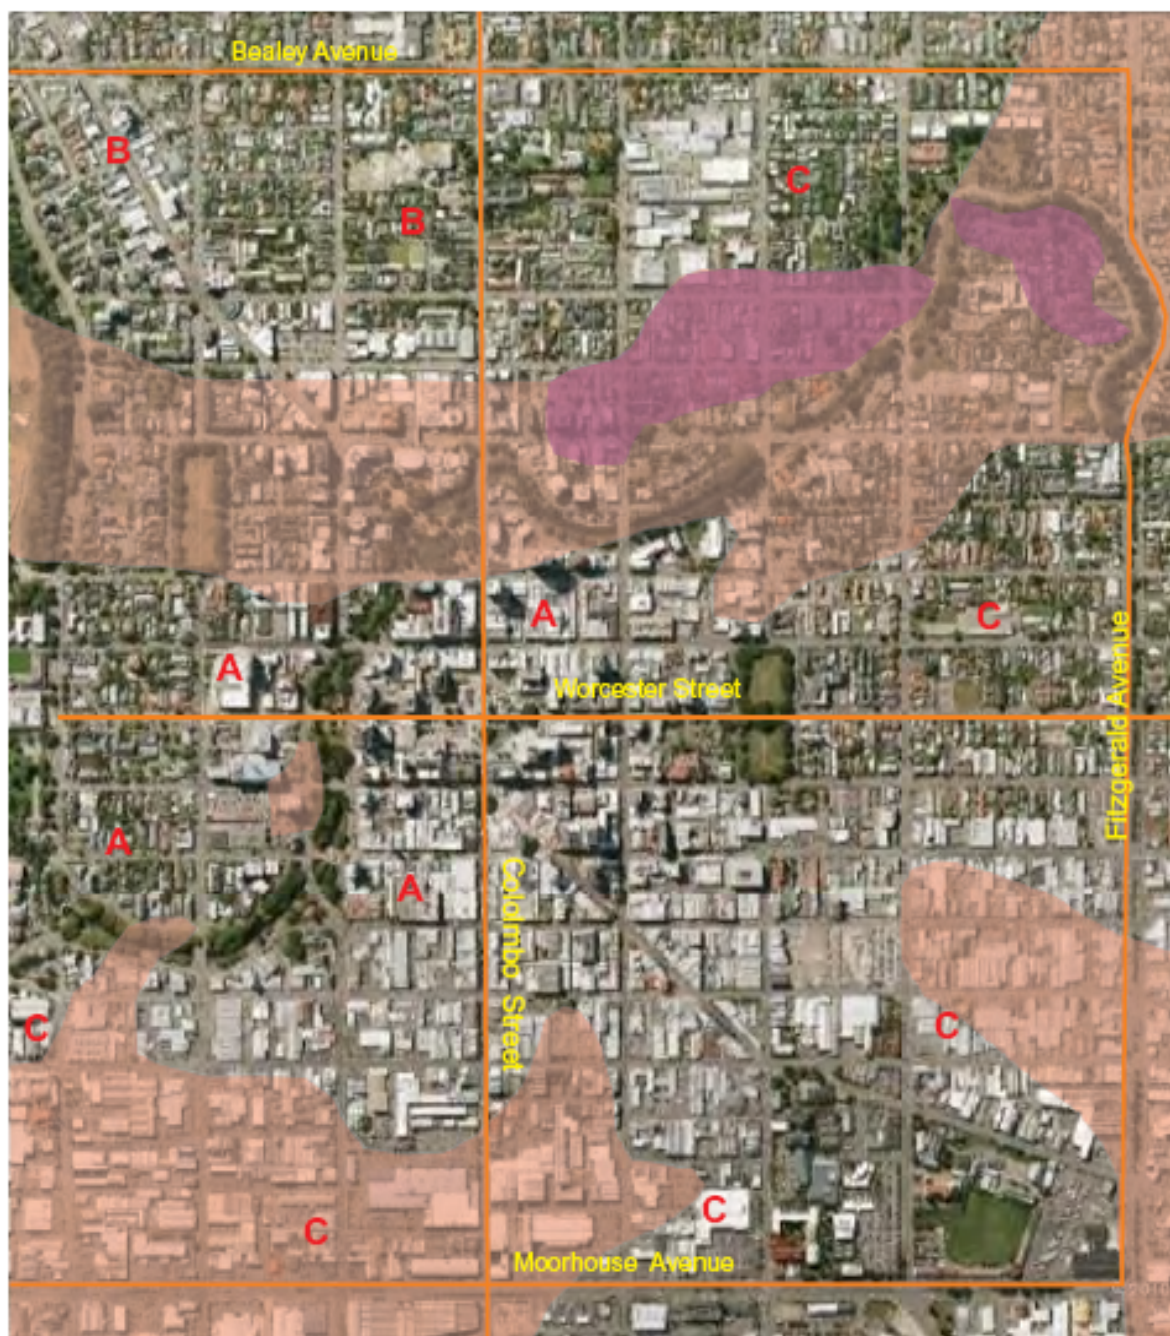
Figure 4-3: Observed Soil Damage Within Four Avenues from Feb 22<sup>nd</sup>  
(Misko Cubrinoski and others)

Shaded areas denote liquefaction damage with sand and water ejection, ground fissuring etc. They are indicative only in that not all parts were damaged to the same degree, or damaged at all. Small areas of sand ejection also occurred in places outside shaded areas. Liquefaction may also have occurred in areas without surface damage.

6. With reference to Table 4-2: Soil and Foundation Damage Assessment Criteria, if it is determined that geotechnical advice is required, the geotechnical engineer should be engaged at this stage. For further guidance of areas of local ground damage, refer to Figure 4-3: Observed Soil Damage Within Four Avenues from Feb 22<sup>nd</sup>, below.

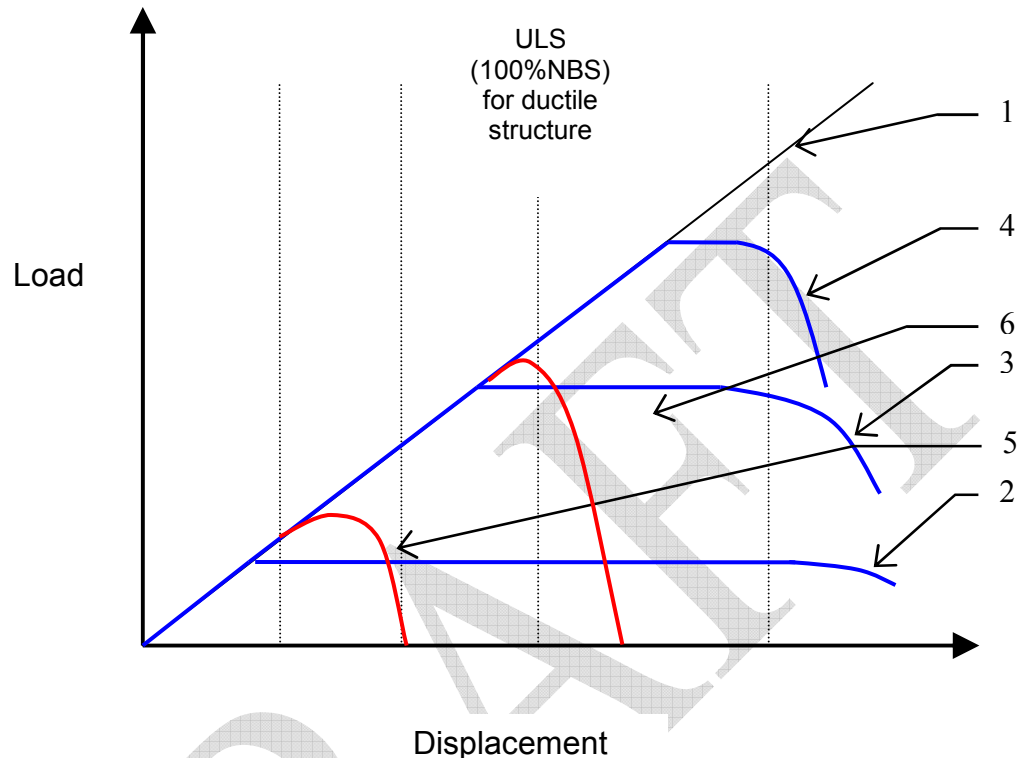
of structures of differing levels of ductility, and hence resilience. In this figure, the blue lines represent new buildings of differing levels of design ductility and the red lines represent existing buildings with differing %NBS capacity.

Figure 6-1: Load-Displacement relationships for buildings

Engineers must recognise that an important aspect of resilience is determining the ability of the structure to deform beyond the displacements predicted for the ULS. If the assessment of an existing building is focussed purely on the overall building strength, it may not verify that the required level of resilience is being achieved. This is illustrated in Figure 6-1 below, which illustrates the load displacement relationships

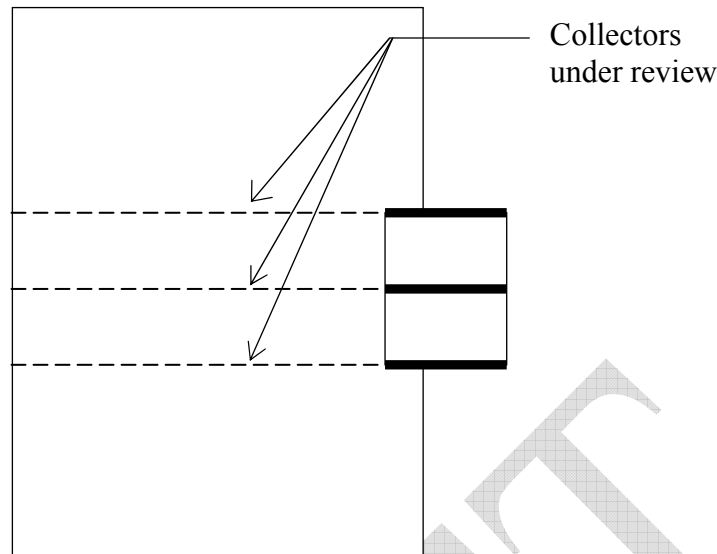
Figure 6-2: Example building floor plan

Floors are precast double tees or similar, floor loading is office. Cladding is lightweight.

Basic plan dimension 30m x 20m and the building is otherwise regular over height.
